Analyzing a Fatal Crane Accident

Investigation reveals practical preventive measures

By Wayne Johnson and Risto Rautiainen

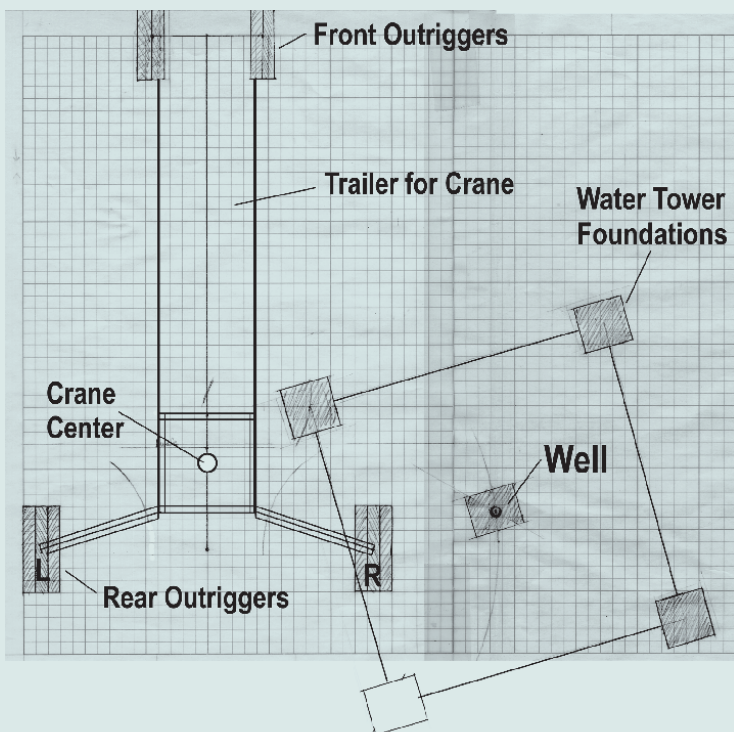
Figure 1

The exposed sections of the four concrete foundations for the tower were 24 ft., 10 in. apart (Figure 1). The four legs of the water tower were bolted to these concrete pads, and horizontal struts and tightening rods were in place to keep the supports square.

The crane was positioned at an angle to the water tower foundations, as close to the water tower as possible (Figure 1). This type of tower crane has four outriggers, two at the front (adjacent to the trailer edges) and two at its rear. The front outriggers are secured to the right and left sides of the transport trailer; they have no lateral movement but are hydraulically driven downward to level the crane. The two rear hydraulic outriggers are on nine-ft. extended beams, which produce a center-to-center distance between these outriggers of 27 ft. These outriggers swing into position manually, then are pinned in place with a steel strut. Each beam is extended hydraulically, forcing the outrigger pads downward to level the crane.

Diagram of Work Area

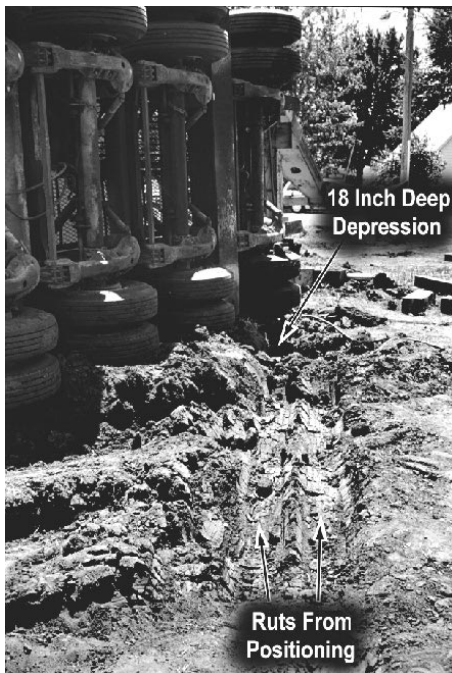
Figure 2

Bolted Cribbing Timbers

The manner in which timbers were placed under the outriggers contributed to the incident as well. As Photos 4 and 5 illustrate, just before the incident, the cribbing timbers were rolling out from under the outrigger pads and spreading apart. Some crane companies report that they always (even if setting up on highway concrete) use plywood or steel plates under outrigger timbers to minimize shifting of the soil and/or cribbing rollout. In addition, some operators use long bolts through timbers to create a solid base in order to prevent cribbing rollout (Figure 2).
