Lessons Learned

A review of published investigation reports from the Charleston Sofa Super Store fire

By Frank J. Baker

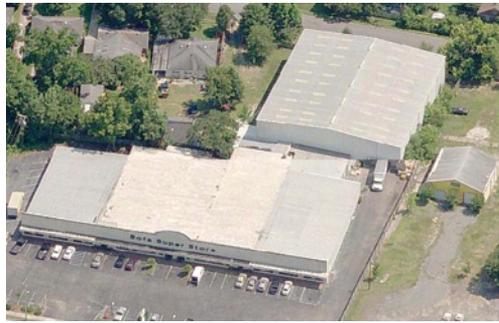
Photo 1 (top): Aerial view of the building before the fire, facing south. Refuse had accumulated near the loading dock located between the front and rear sections of the building.

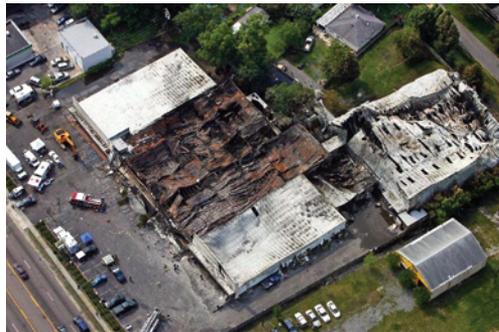
Photo 2: Aerial view after the fire. Note the extensive collapse of most of the structure. Roof coatings in the center section of the front showroom contributed to the heavy fire load and were also consumed in the fire.

Concealed or void spaces above the showroom ceilings and a roof coating of combustible polyurethane foam caused heat and products of combustion to become trapped and spread laterally through the structure without being easily detected at the floor level where the firefighters were. This void space between the suspended ceiling and the roof created an uninterrupted plenum between 2 and 6 ft high depending on the slope of the roof at that location (Routley, et al., 2008, p. 39). (Investigators concluded that a thermal imaging camera would have readily identified these conditions.) A similar condition began to occur below the ceiling. This was visible to the firefighters, but it was only part of the problem.

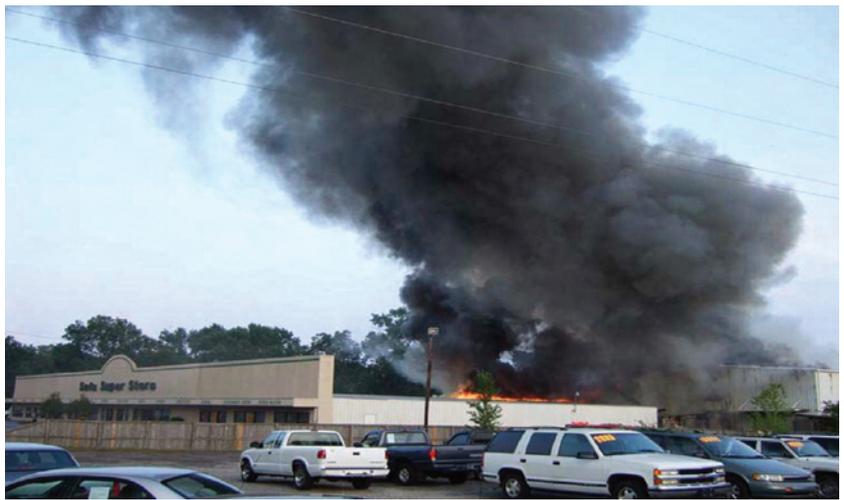
Photo 3: View of the building from the adjacent property to the west. By this point, the fire had spread from the loading dock area to the main showroom.

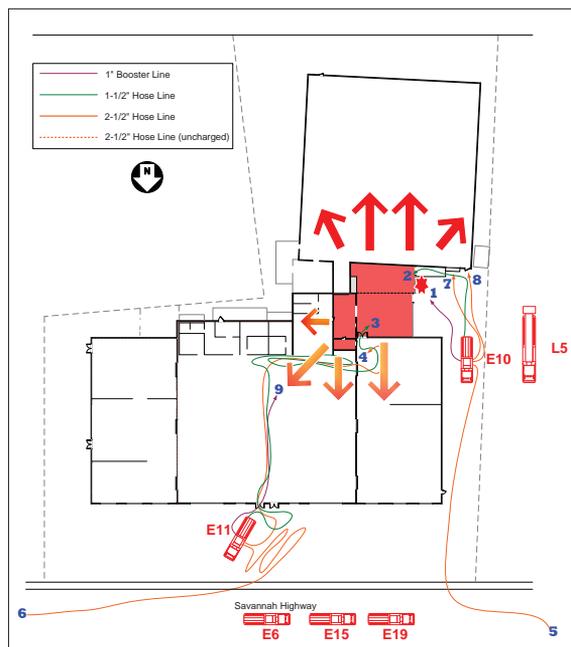
The most likely cause of the fire is believed to have been carelessly discarded smoking materials that ignited trash outside the loading dock, which in turn ignited furniture stored inside the loading dock, eventually spreading throughout the building (Photos 1 and 2, p. 35). The fire spread through concealed spaces above the heads of firefighters—meaning the firefighters were unaware of how rapidly the conditions were deteriorating. The fire also communicated unchecked through unprotected doorways and directly penetrated walls that were not constructed of fire-rated materials to reach more fuel (see diagram below). By 7:52 p.m., the roof of the west showroom began to sag due to heat exposure and at 7:56 p.m., the center showroom roof suffered a catastrophic collapse (Routley, Chiamonte, Crawford, et al., 2008, pp. 53-80).

Diagram from the investigation team's Phase 2 report shows the direction of fire travel from the point of origin outside the building.

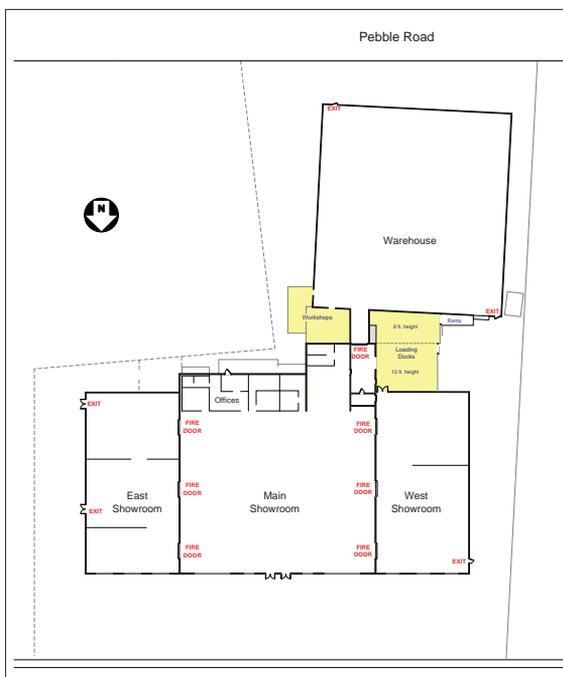
Diagram from the Phase 2 report shows those sections built without city approval—highlighted in yellow. These sections enclosed previously required exits and provided pathways for fire to travel around the fire door that was installed to separate the showroom and warehouse sections.

After 1996, several small wood frame additions covered with metal siding and roof decking were added to create what are termed *fill-in* additions. These typically take advantage of existing walls of one or more already built structures and effectively fill in the space between them with a floor and roof (see diagram above).

In this case, no building permits were obtained for these additions—nor is it likely they would have been approved. These additions caused two primary problems: 1) they circumvented the fire separation created by the enclosed tunnel with a fire door that was intended to separate the showroom from the warehouse; and 2) they enclosed previously required exits. This created dead-end rooms that would later house high-hazard operations. During the fire, firefighters had to forcibly break through one of the exterior walls to rescue a trapped employee (Routley, et al., 2008, p. 31).

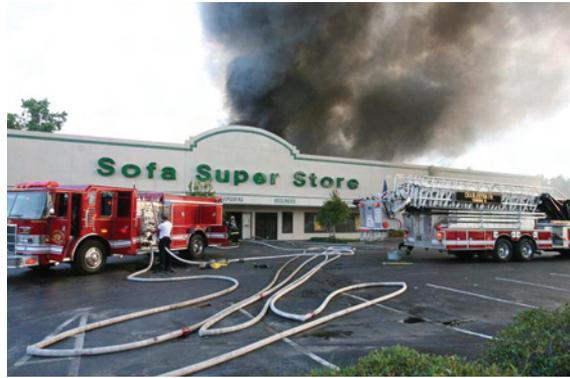
Photo 4: Water supply lines were extended from the nearest fire hydrants and hose lines extended far into the building. The kinked single supply hose in the foreground indicates inadequate incoming water pressure—resulting in inadequate water flow to the pumping engine.

Later in the operations, master streams would be set up that caused the demand to exceed the water main and hydrant capacity in the area (Routley, et al., 2008, p. 128). Master streams are large flow water application devices for 300 to 2,000 gpm that can either be set up at ground level or from elevated positions such as aerial ladder trucks. They are designed for defensive fireground operations to apply large amounts of water to prevent fire spread from the building of origin by suppressing the fire or to adjacent structures by cooling their exterior surfaces due to radiant heat exposure (Hall & Adams, 1998, p. 596).

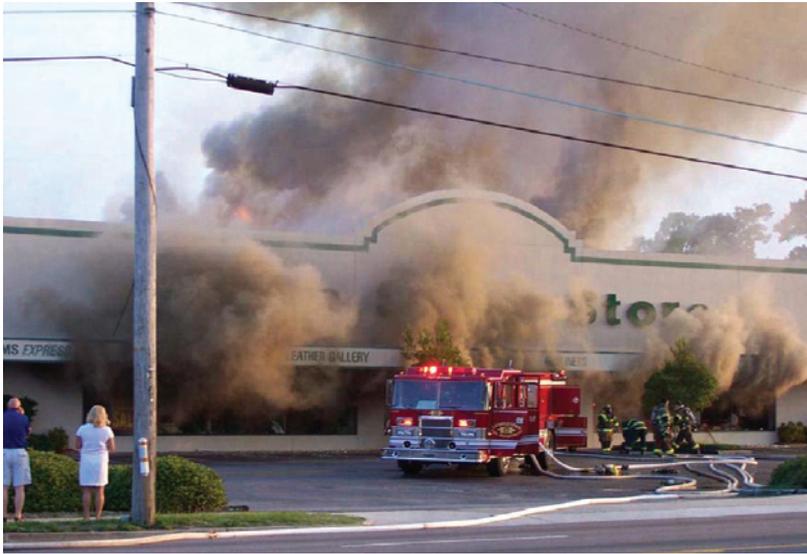
Photo 5: Shortly after the front windows of the building were removed in an effort to horizontally ventilate the building, the fire grew rapidly inside. Without adequate water supply for the hose lines inside, there was little hope of controlling the fire.

Other problems with the building construction that prevented traditional roof ventilation operations were the lack of natural openings in the roof (Photo 5) and the design of the front parapet wall behind the entrance facade. The height of the front parapet wall prevented normal ladder operations from being conducted via the front side of the building where there was space to set up the aerial ladder (Photo 6).

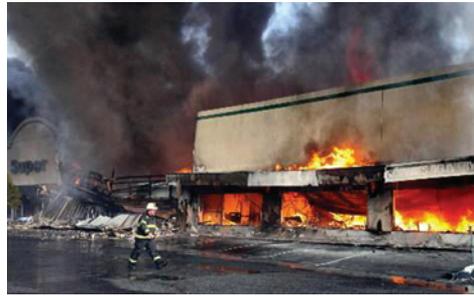
This 23-ft-high parapet was part of the original construction and the two flanking additions to give the appearance of a much larger building above the existing 12- to 14-ft building roof line. It was strictly a cosmetic feature and would prove to be a significant impediment to roof operations (Routley, et al.,

Photo 6: The building façade that created a parapet wall at the front of the building that prevented access for normal roof ventilation collapsed along with a major portion of the roof.

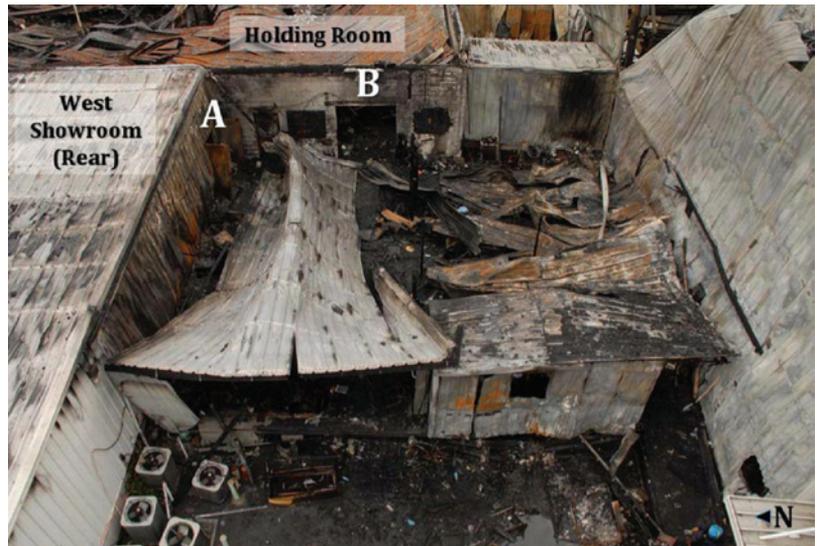
In this case, the most critical factor was that the building created its own exposures. This was caused by lack of proper fire separations and opening protection that permitted the fire to extend from its area of origin by communicating through unprotected openings or directly through the metal siding into three adjacent areas (Routley, et al., 2008, p. 85).

Photo 7: Photo shows total collapse of the loading dock area. Fire penetrated through unprotected wall openings and through wall construction materials to spread in three directions.
