Anatomy of a Confined Space Fire

A case study and lessons learned

By Martin H. Finkel

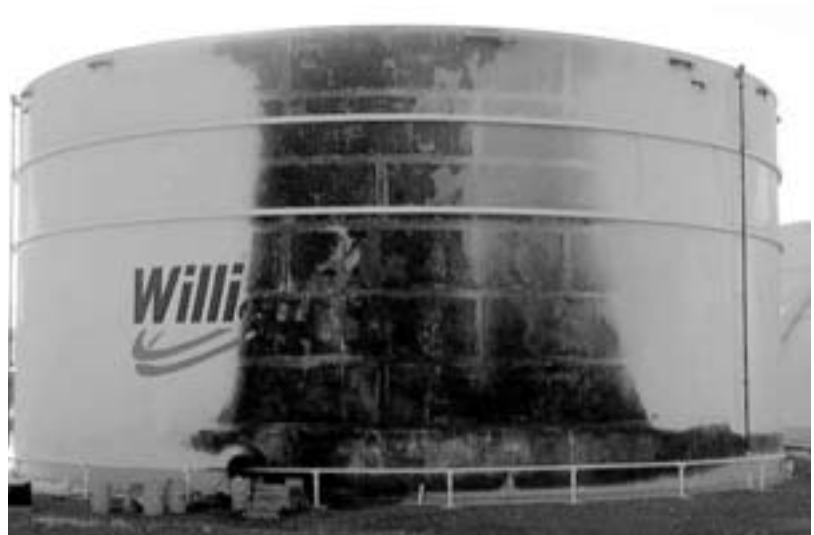
ON APRIL 6, 2000, TANK T-1001 at the Williams Petroleum tank farm at the Port of Anchorage, AK, erupted in flames. Photo 1 depicts the aftermath of the fire—its heat having scorched the exterior coating. Although no one was seriously injured or killed, it could have easily been otherwise. This article explores the fire and its causes, as well as lessons that can be learned from this incident.

The fire department took a considered approach to the fire and was able to extinguish the burning naphtha inside without endangering response personnel. The heat inside the tank was sufficiently great so that the floating roof was melted and distorted and needed to be replaced. The cost of this incident was considerable, but much less than could have been the case considering the lack of injuries to personnel.

Photo 1 (top): The aftermath of the fire in tank T-1001.

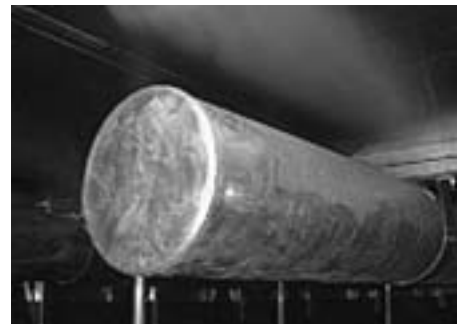
Photo 2: One configuration of a floating roof is a flat layer of steel plate with attached floats or “pontoons.”

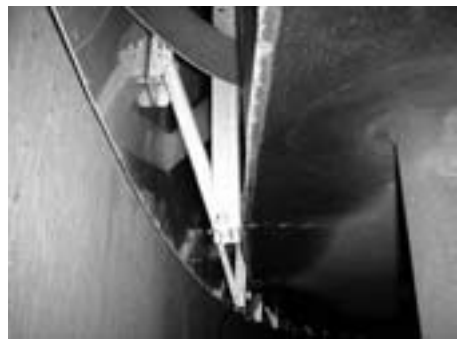
Photo 3: A shoe-type seal is slightly more costly than a log-type seal, but has a much safer design.

The type of seal used in this tank is particularly dangerous. The cost of using a shoe-type seal, where the elastomeric flap is pressed against the side of the tank by a spring-loaded “shoe” (Photo 3), is only slightly higher than that of the log-type seal. The shoe-type seal has a much safer design, as it cannot trap a significant amount of product. Facility owners worldwide are urged to investigate the type of seals used in their storage tanks with floating roofs, and to make appropriate plans to replace those seals with hollow spaces as soon as is practical.
