# Asbestos Abatement

*Innovation drastically reduces construction duration*

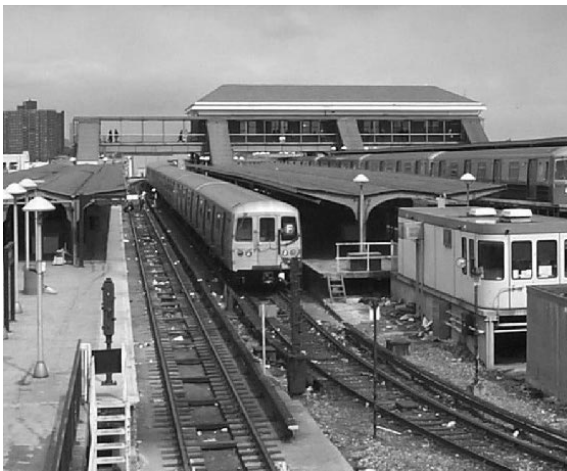
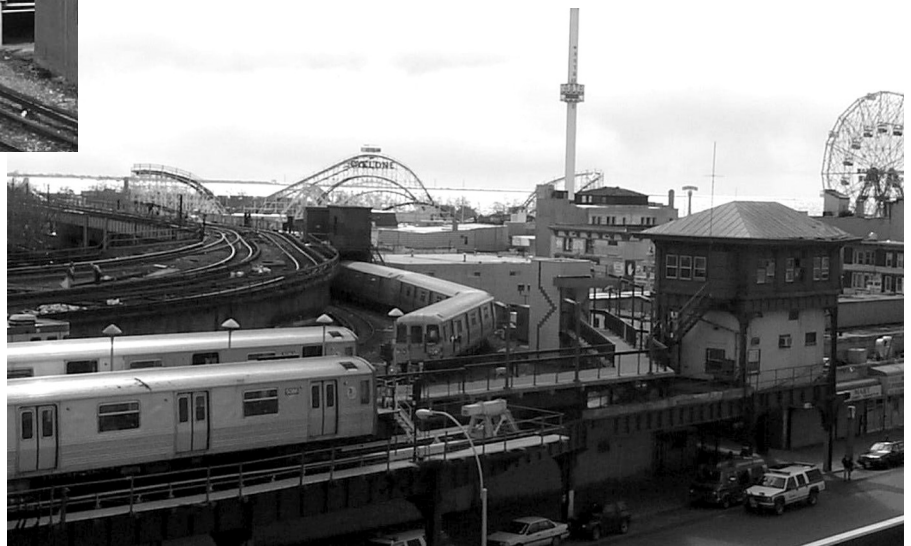
**Photos 1 and 2:** The Stillwell Avenue train terminal was built between 1915 and 1919 as part of the Brooklyn-Manhattan Transit subway system; it is an elevated station located on property owned by MTA. The train serves as a primary connection to local attractions such as the shore amusement parks, beaches, parks and a nearby minor league baseball stadium.

The Stillwell Avenue train terminal was built between 1915 and 1919 as part of the Brooklyn-Manhattan Transit (BMT) subway system; it is an elevated station located on property owned by MTA (Photos 1 and 2). The terminal rests along the east side of Stillwell Avenue, between Neptune Avenue on the north and Surf Avenue on the south in the Coney Island section of Brooklyn. It is primarily a viaduct

structure that consists of eight tracks and four island-type platforms. A 1989 engineering study found delaminated, spalled and porous concrete deck and encasements to be beyond repair due to severe water infiltration, which led to corresponding corrosion damage within the supporting steel members.

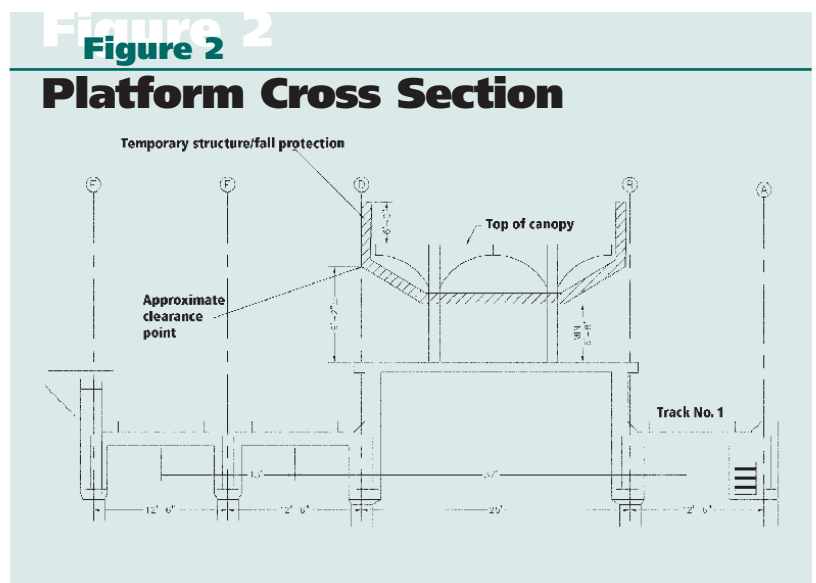
To meet these requirements, the abatement contractor retained the services of a professional engineer who designed an intricate plywood and steel-clamped envelope structure (Figures 1 and 2).

The main element of the abatement plan design called for use of a plywood envelope to isolate the canopy portion from the rest of the structure. Although preparation of containment is a requirement for most asbestos abatement projects, it is not typically an element for abatement of non-friable material in the open environment.

The multiple functions of the isolation envelope were detailed in the project specifications: 1) Account

for the necessary loading created by equipment and workers on top of the structure.

2) Provide wind-resistance against the predictably high winds at the shore.

3) Maintain water-tightness and drainage since the envelope would be open to the elements on top.

4) Serve as a vision barrier that would inhibit the line of sight to the ongoing abatement work from neighboring properties.

5) Provide fall protection measures for abatement workers and inspectors above the canopy. (See 29 CFR 1926.)

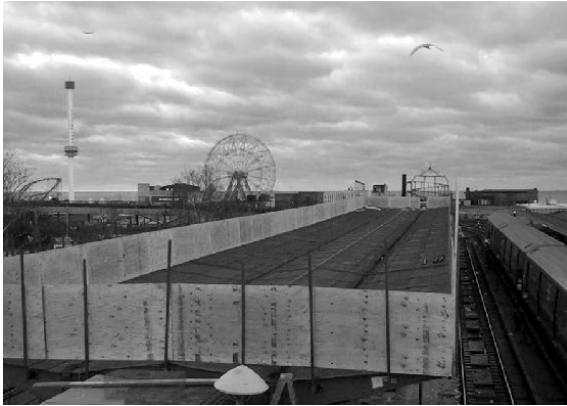
**Photo 3: With the envelope in place above the canopy, the platform was able to remain open with normal rider activity while asbestos abatement work occurred directly overhead.**

This train, consisting of a diesel engine car and several flatbed cars, used the deactivated track. With the platform temporarily clear of passengers, the envelope was constructed with a minimal grade for water collection, measured precisely on the track side to ensure compliance with train clearance parameters once inside the station limits, secured to the steel lattice of the canopy structure, lined inside with reinforced plastic sheeting, and foamed sealed in time to restore train service and reopen the platform by the Monday morning rush. With the envelope in place above the canopy, the platform was able to remain open with normal rider activity while asbestos abatement work occurred directly overhead (Photo 3).
