# Stairway Falls

*An ergonomics analysis of 80 cases*

**By Joseph Cohen, Cindy A. LaRue and H. Harvey Cohen**

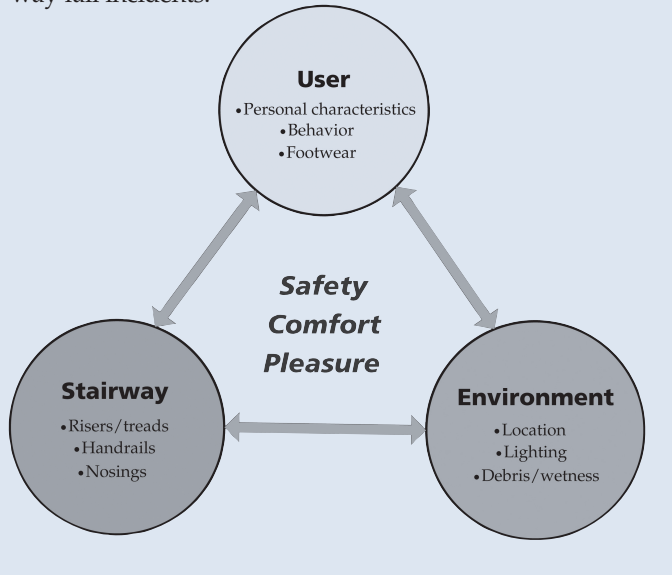
**Figure 1**

## Model Used for Study

User-stairway-environment systems safety model of stairway fall incidents.

The ergonomics-based systems safety model adopted in this research served as a conceptual framework for analyzing the 80 cases (Figure 1). In systems thinking, one assumes a dynamic and interactive relationship between the elements involved in the use of a stairway—namely the user, stairway and environment of use. Harmony between the elements ensures positive outcomes when using stairways—namely safety, comfort and pleasure.

Therefore, when examining stairway fall incidents, it is critical to consider not only the user's behavior, but also the stairway's characteristics, the environment of use and the interaction among them. The ergonomics-based systems safety model specifies that stairway falls most often have many contributing factors rather than one root cause.

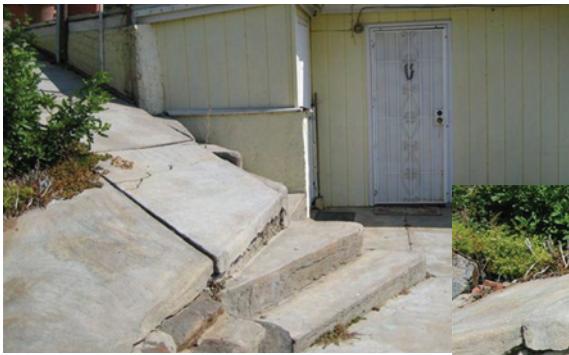
**Photo 1:** This stairway has high degree of variation in both riser heights and tread depths. If a riser is too high or too low, a person navigating the stairs may find it difficult to maintain safe footing. Treads that are too short force the stair user to either rest only part of a foot on each tread or to twist the foot unnaturally.

highest measured 10.375 in. For the most part, the risers in this investigation ranged from 5 to 7.5 in. The treads in this investigation ranged from 8 to 35 in., with the treads of most of the staircases falling between 10 and 12 in. Photo 1 shows a stairway with a high degree of variation in both riser heights and tread depths. The top tread narrows down to 2 in. on the far left side. This extreme dimensional variation, combined with the excessive slope of the walking surface, lack of a handrail and insufficient lighting created a very unsafe stairway.

Sixty percent of the stairs in this study were found to have riser variations of greater than 0.375 in. The greatest variation was a stairway with a 6-in. variation in the riser heights. The average riser variation for the investigated cases was approximately 0.625 in., a full quarter-inch more than the amount of variation allowed by the model codes. Explanations for these variations include the natural settling during the life of the staircase, poorly maintained structures and conformance to fit existing sidewalk or terrain, as well as design and construction flaws.

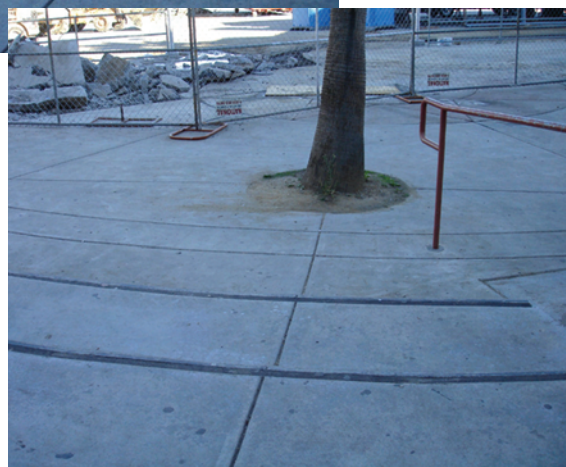
**Photo 2:** This half-round stair has an unusually long tread. The step edges could be made more conspicuous with hazard yellow striping and an intermediate handrail. Also note the deceptive visual cues created by nearby expansion joints, and the adjoining ramp handrail (to the right) which is excessively long.

Photo 2 depicts the stairway in question. The half-round stair has an unusually long tread (35 in.), the edge of which was not conspicuously marked with, for example, hazard yellow striping. The lack of an intermediate handrail more within the normal line of sight also was considered to be a contributing factor to the injury incident. Such a handrail would have provided a more obvious visual cue to the subtle change in elevation.

Deceptive visual cues, including the presence of expansion joints that blend in with the grooves along the step edges, as well as an exceptionally long handrail to the right (as one descends the stairway) and one bordering the left edge of an adjoining ramp, were also implicated as contributing factors.
