Mercury Contamination

Review of a Residential Response

By Marcella R. Thompson

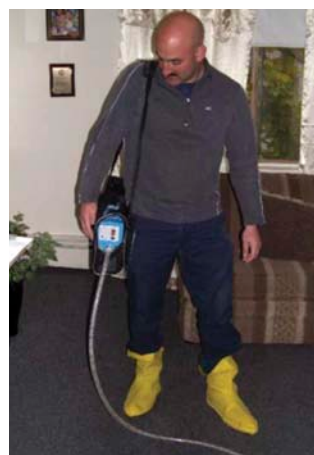
Overall, the highest readings were found in apartment entryways and the lowest in the bedrooms. Highest readings were generally found at floor level.

In 62% of the apartments, the highest reading was found in the apartment’s entryway. In 65% of apartments, the lowest reading was in the bedroom. Sixty-eight percent of the highest readings were found at floor level (Table 5, p. 53).

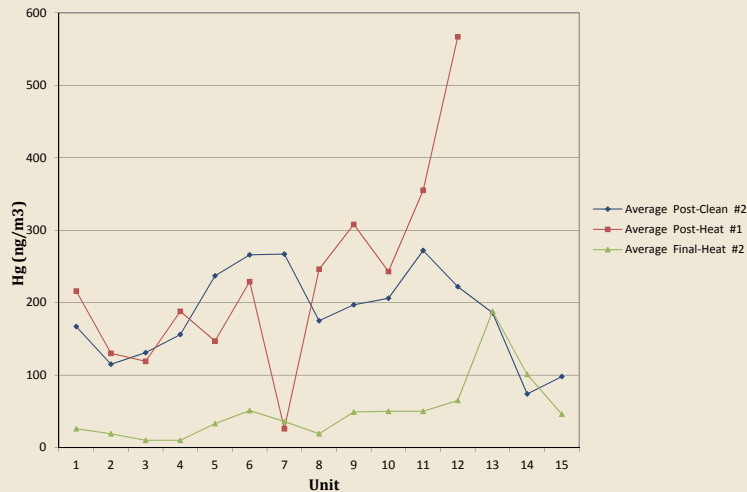
tation error. Figure 1 illustrates the average mercury levels taken after a second round of cleaning and after each round of heating/ventilation. While initial readings (post-clean no. 2) were below 300 ng/m³, the readings after the first heat-vent cycle clearly shows the release of additional mercury vapor. In 43% of the units, mercury vapor levels increased post-heating over post-cleaning. Readings taken after the second heat-vent cycle were less than or equal to 100 ng/m³ with one exception.

Mercury Vapor Readings Post-Clean & Post-Heat Cycles

Within each building, post-heat measurements had to satisfy the screening protocol before clearance sampling was conducted; that is, 90% of readings had to be less than 300 ng/m³ and 100% less than 360 ng/m³. This was to account for the direct-reading mercury vapor analyzer's $\pm 20\%$ instrumen-
