# Water Harvesting

## Reducing Pollution & Enhancing Revenue to Protect the Triple Bottom Line

By Albert Weaver III and Carl Simmons

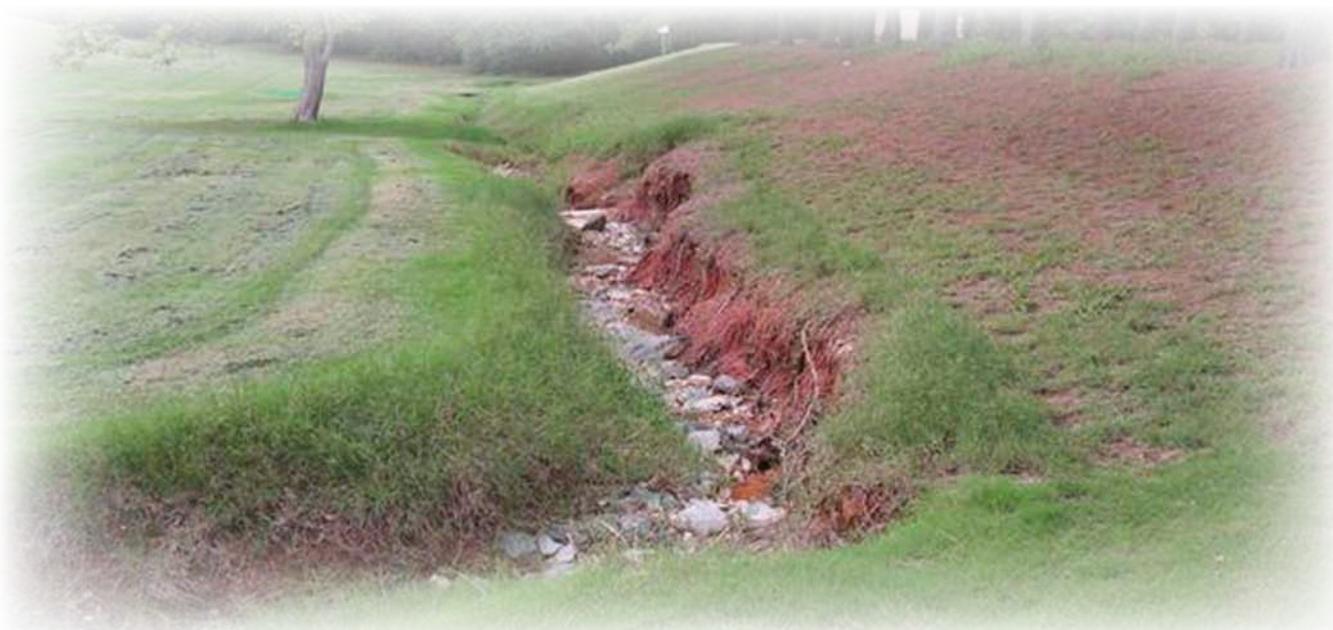
Erosion on the golf course was one of the concerns that prompted the project.

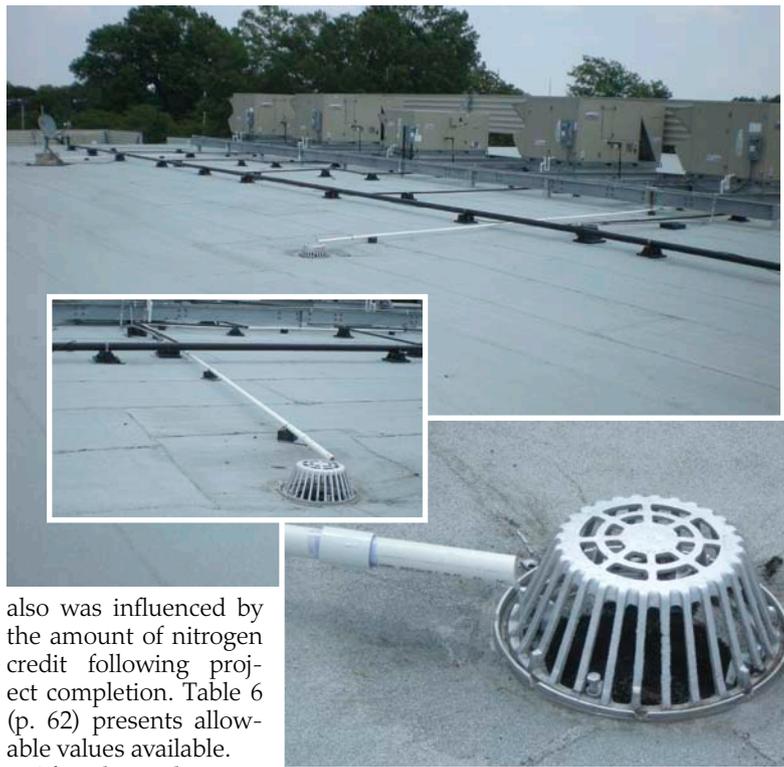
Roof drainage captures HVAC condensate from 15 units plus rainfall.

While this project was being explored, the club was renovated and its HVAC system was upgraded with the addition of 15 self-contained heating and air condition units installed as roof-mounted units. These units were determined to produce about 500,000 gallons of water annually. In addition, overwash from tennis court irrigation was another source, again not quantified, but determined to be substantial based on wet spots continually noticed on the areas of the golf course where it drained. Another source was water runoff from a four-lane highway adjacent to the club property that was directed onto the property. Finally, storm water runoff from about 20 acres of the property, some pervious and some impervious, could be captured and reused.

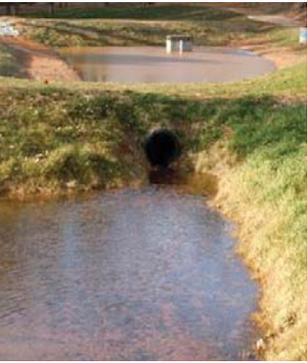
Completed pond in the background and forebay has helped the club conserve water.

Water then flows from the forebay to the pond. The pond has 19,383 ft<sup>3</sup> (145,000 gallons) capacity; it also receives water from the forebay, from the discharge of the four-lane highway on its east side, and from storm water runoff from elevations greater than 435 ft on the pond's south and west sides.

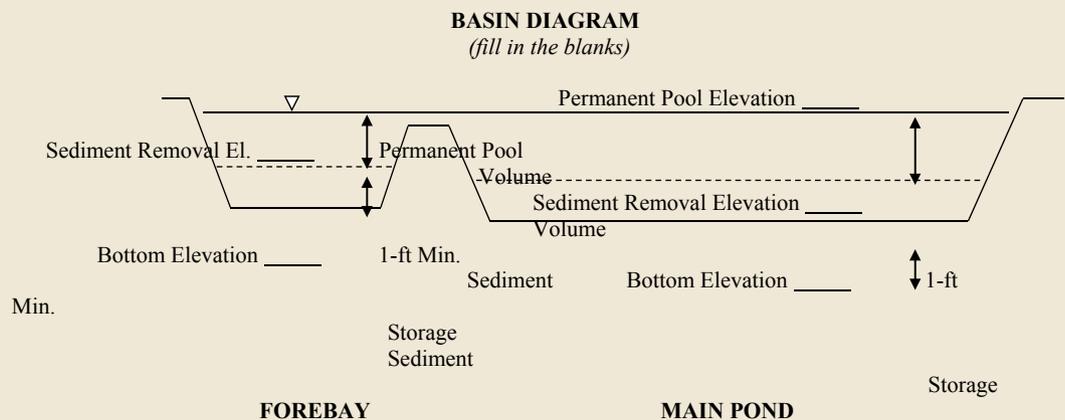
**Figure 1**  
**Basin Diagram**

Sedimentation control and removal are based on the permanent pool depth of the pond. The NC Department of Natural and Environmental Resources (2007) offers and recommends design parameters (Figure 1, p. 64) to establish maintenance criteria for sediment removal. As noted, "When the permanent pool depth reads x ft in the main pond, the sediment shall be removed. When the permanent pool depth reads x ft in the forebay, the sediment shall be removed."

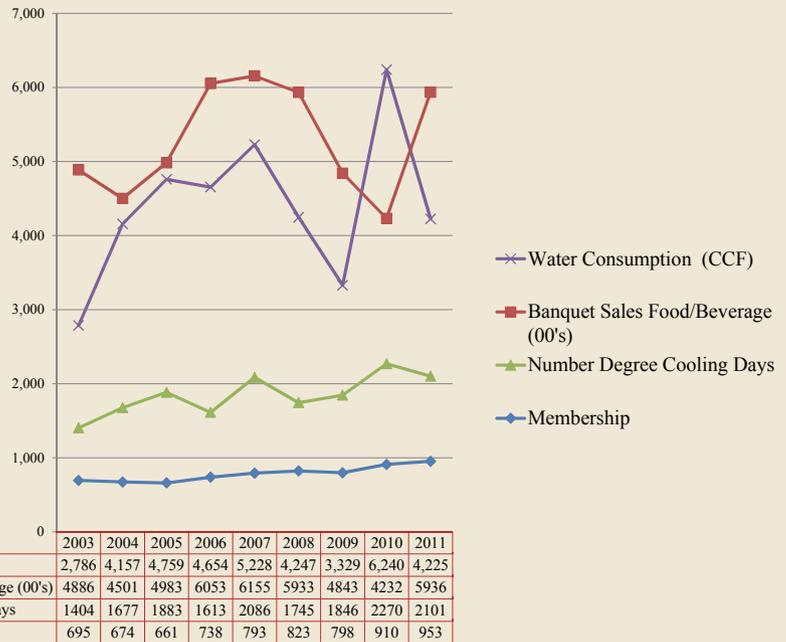
**Figure 2**  
**Water Consumption 2003-2011**

Quantifiable results include economic, social and environmental impacts. The economic benefits are now being realized. The club began using the harvested water in 2011 for golf course irrigation. As a result, the club reduced water purchases in 2011 by more than 1.5 million gallons, a 32% decrease from 2010 purchases, despite a 5% increase in club membership, a 40% increase in banquet food and beverage sales, and almost the same number of degree cooling days for 2011 compared to 2010 (7% decrease). Purchasing 1.5 million gallons less water at \$0.016 per gallon saved the club more than \$24,000 in 2011 and is higher than the amount initially projected to be saved annually when the financial payback period was calculated (Figure 2, p. 65).
