FORKLIFT SAFETY

A Pilot Study Evaluation of Retrofit Lights

By Thomas G. Bobick, Mathew Hause, Christina Socias-Morales,
Melody Gwilliam and Tashira Decker

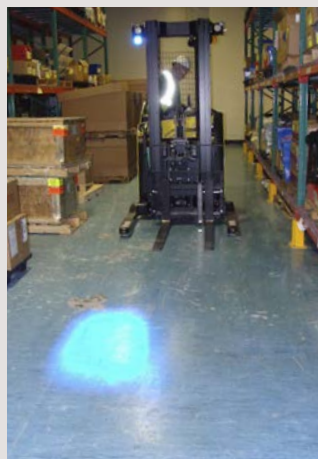
(Counterclockwise from top left) Photo 1: Single forward-facing blue light installed. Photo 2: Forward- and rear-facing blue lights installed. Photo 3: Red lights installed on each side, with the front blue light visible on the storage rack and the rear blue light visible on the floor (right edge of photo).

ed during July, August and September 2017, provided NIOSH researchers an opportunity to become familiar with the plant operation. The first retrofit modification, which occurred in October 2017, involved installing a blue light on the front of the overhead protection on all three forklifts (Photo 1). A follow-up visit was conducted in January 2018 to observe vehicle usage with the blue lights in the forward direction. The second modification completed by the forklift distributor's technician occurred in March 2018 and involved the installation of the second blue light on the rear of the canopy for all three forklifts (Photo 2). Follow-up visits occurred during May and June 2018. Finally, the third modification occurred in August 2018 and consisted of installing red lights (Photo 3) on both sides of the three forklifts to provide an indication of the turning radius (rear-end swing) as a warning to pedestrian workers. Two follow-up visits were scheduled during August and September 2018 when both blue and red lights were operational. All eight site visits were conducted by the two NIOSH researchers and each site visit lasted for 7 hours.
