Implementing Effective Fall Protection Practices In Residential Construction

**Thomas Trauger, ARM
Winchester Homes
Bethesda, MD**

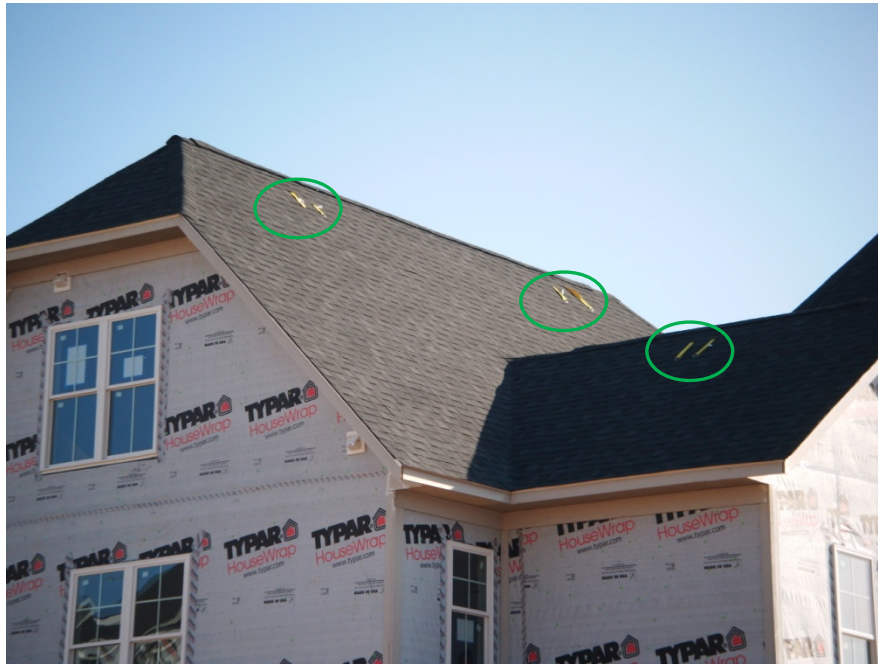
Exhibit 1. Permanent roof anchors installed for trades to use.

Winchester Homes is one of five companies that is part of the Weyerhaeuser Real Estate Companies (WRECO), which builds homes in Maryland and Virginia. Winchester Homes both develops land and buys finished lots to build single-family homes and town homes. Using the "Your Home Your Way" process, buyers can modify the home at will. Therefore, Winchester seldom builds the same house twice. Besides options and finishes, major structural changes are commonly conducted on base-type homes. Over 100 subcontractors are used to complete over 100 building phases. In 2007, the WRECO management team started the implementation of fall protection practices that met or exceeded Subpart M, phasing out practices that met the OSHA interim fall protection guidelines (OSHA STD 03-00-001). Permanent roof anchor points have been installed on all Winchester Homes sites for over eight years (shown in Exhibit 1).

Once all of the trusses are set and braced, the roof sheathing process starts. Permanent anchor points are then installed in each roof plane. Depending on the size of the home, more than one anchor point may be installed on the roof plane (shown in Exhibit 1). The worker hooks in to the permanent points with a retractable line and harness and continues sheathing the roof (shown in Exhibit 17). Any additional work conducted on the roof can be done using the permanent anchor points and PFAS.

For the past several years, Winchester Homes has been installing anchor points at the framing stage between two trusses, and then sheathing over them and leaving them in place until the house is completed (shown in Exhibit 1). These anchor points are used by several trades working on the roof. Using anchor points on fully sheathed roofs meets the truss manufacturer's recommendations and complies with Subpart M and ANSI Z359 requirements. A fall protection solution for framers working off of inside walls while installing trusses and then sheathing the roof was needed (shown in Exhibit 16). In the past, they would follow the interim fall protection guidelines, and framers installed the first three trusses from a ladder and then temporarily braced them. Then the worker installing trusses in the middle of the house would climb into the web of the braced trusses and continue installing trusses. Sheathing was conducted by installing the first few boards from ladders and the web of the trusses, then installing slide guards and continuing to sheath the roof (shown in Exhibit 17). During this task, they would install the anchor point.

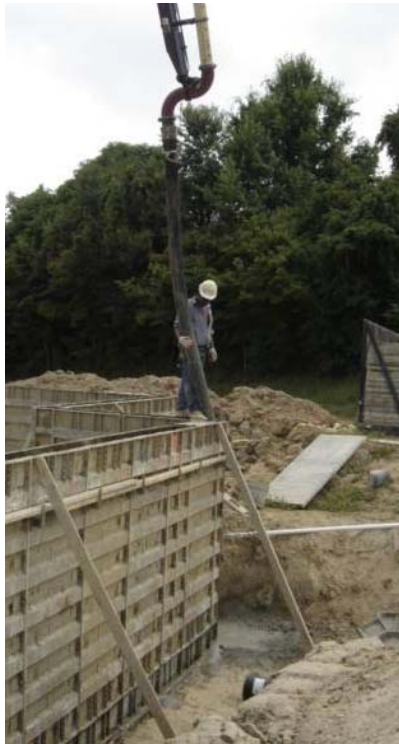
Exhibit 3. Concrete worker walking forms while pouring basement walls.

Most contractors doing this type of work for residential construction also do it for commercial construction. This made it easy to implement a safety practice on home-building sites. The practice of walking the top of the form walls (shown in Exhibit 3) was eliminated by installing scaffold brackets on the forms and planks (shown in Exhibit 4). Installing and removing the brackets and planks require at least two workers and two to three hours of work, depending on the size of the basement. The bracket and planks can be reused and prorated over 100 homes, making the cost an overall low expenditure.

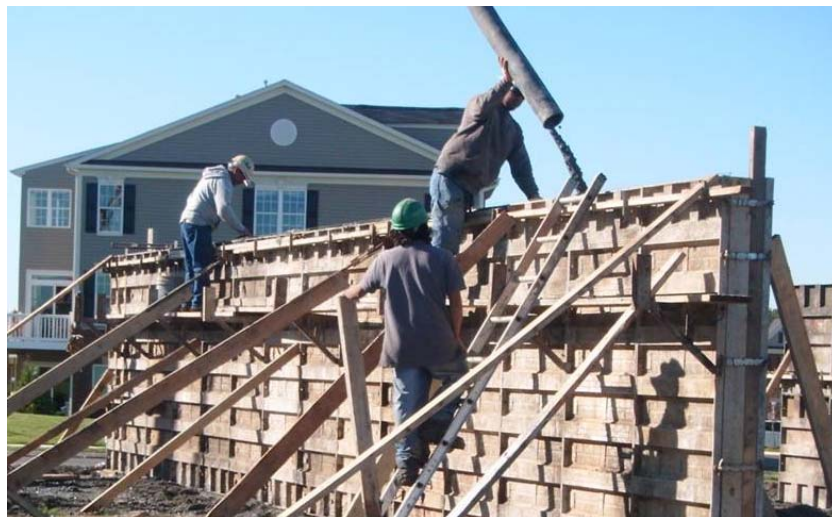
Exhibit 4. Concrete workers working off of bracket scaffold while pouring basement walls.

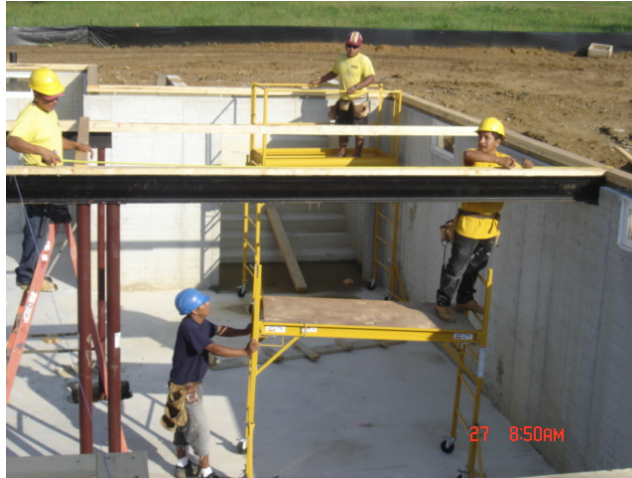
Exhibit 5. Workers setting sill plate on basement walls from ladders and mobile scaffold

The practice of walking basement walls and setting the sill plate and floor joists was eliminated. Framers can work from ladders or scaffolds to complete this task (shown in Exhibit 5 and 6).

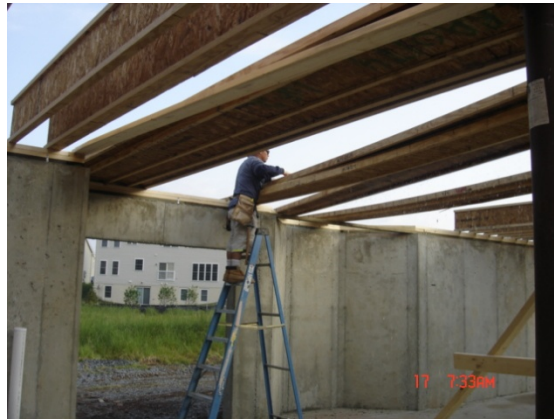
Exhibit 6. Framer working off of a ladder installing first floor joists.

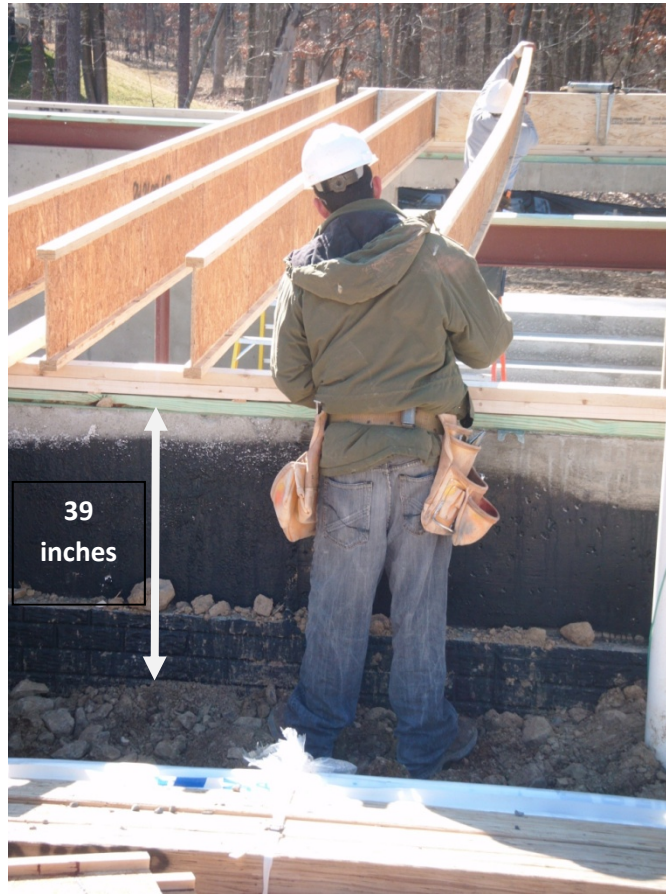
Exhibit 7. Framers installing floor joists from backfilled ground 39 inches from top of basement wall to ground and ladders.

Another practice that was evaluated was partial backfilling, leaving 39 inches from the top of the basement walls to the ground (shown in Exhibit 7). The basement wall acts as a guard rail, preventing falls into the basement. This protects framers installing the sill plate, floor joists, and sheathing. The excavator would come back after the house was framed to complete the backfill.

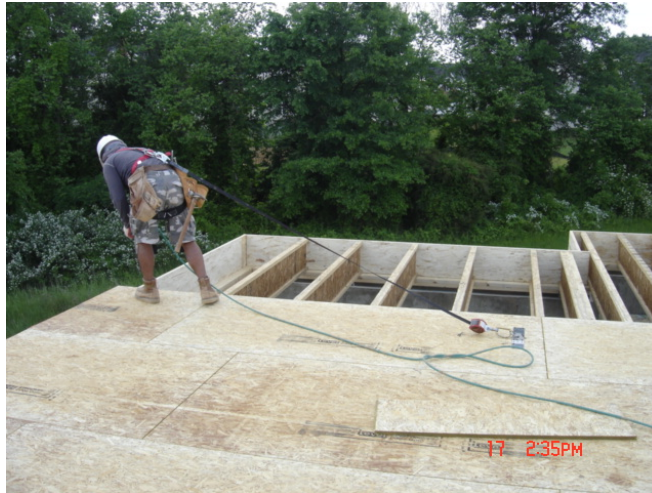
Exhibit 8. Worker using PFAS during installation of floor sheathing.

When a walk-out basement condition exists, there will be a fall hazard greater than six feet from the edge of the first floor; a retractable line, harness and anchor point installed on the floor protects the worker from falling over the edge and falling between floor joists while sheathing the floors (shown in Exhibit 8).

The manufacturer's installation instructions (truss joist) for our floor system require all floor joists and band boards to be installed and fully sheathed prior to applying any loads on it. The manufacturer, Weyerhaeuser (our parent company) was contacted and they provided guidance on how much sheathing is needed on the floor joists to provide structural strength on the floor system and be able to use an anchor point that meets the Subpart M requirements. A recommendation of installing 3 to 4 pieces of 8x4 floor sheathing, preferably in a corner, and spanning as many floor joists as possible, and then installing the anchor point was suggested. Sheathing of the floor is conducted with anchor points installed at the feet (shown in Exhibits 8

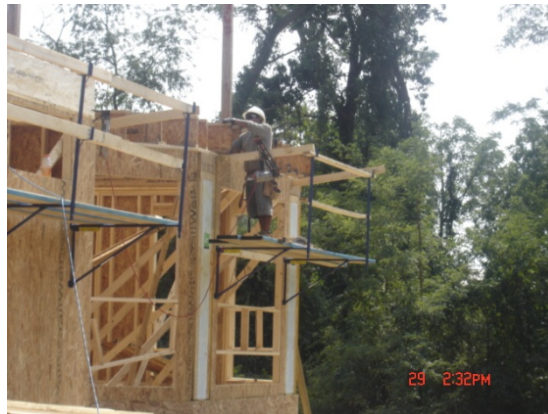
Exhibit 9. Framers working off of carpenter bracket scaffold installing second floor joists.

Installation of second floor joists can be conducted from a carpenter bracket attached to the first floor walls (shown in Exhibit 9), horse scaffold (shown in Exhibit 10) or ladders (shown in Exhibit 11). Framers chose the use of ladders because of availability, ease of use, and cost.

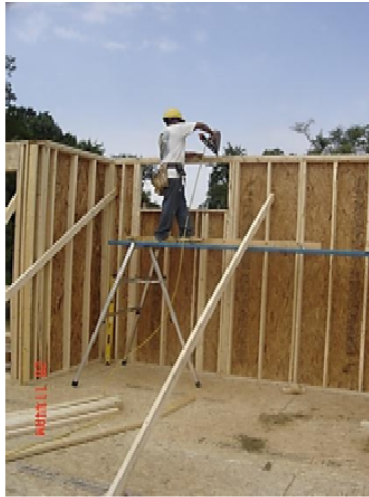
Exhibit 10. Framers working off of horse scaffold tying first floor walls together.

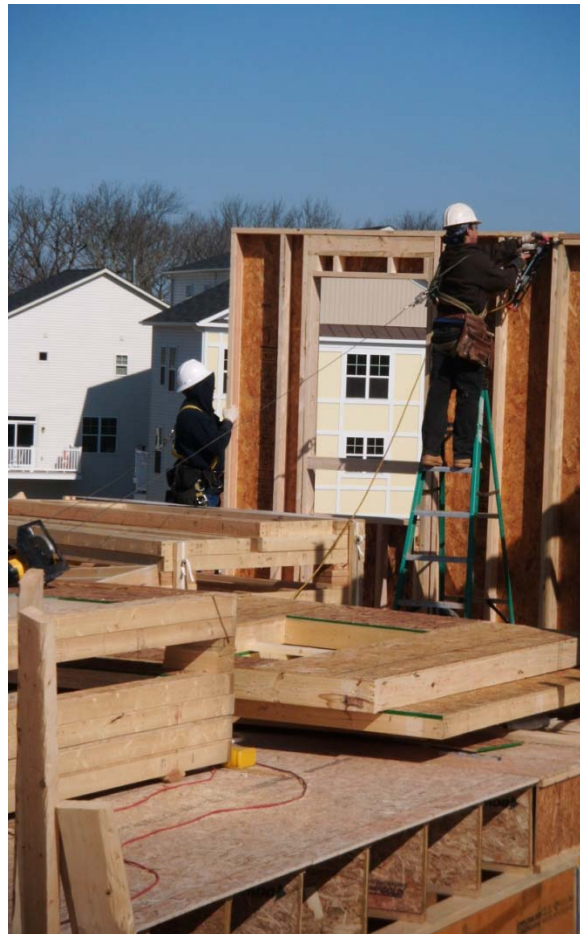
Exhibit 11. Framers installing second floor walls using self retracting lines and anchor points installed on floor.

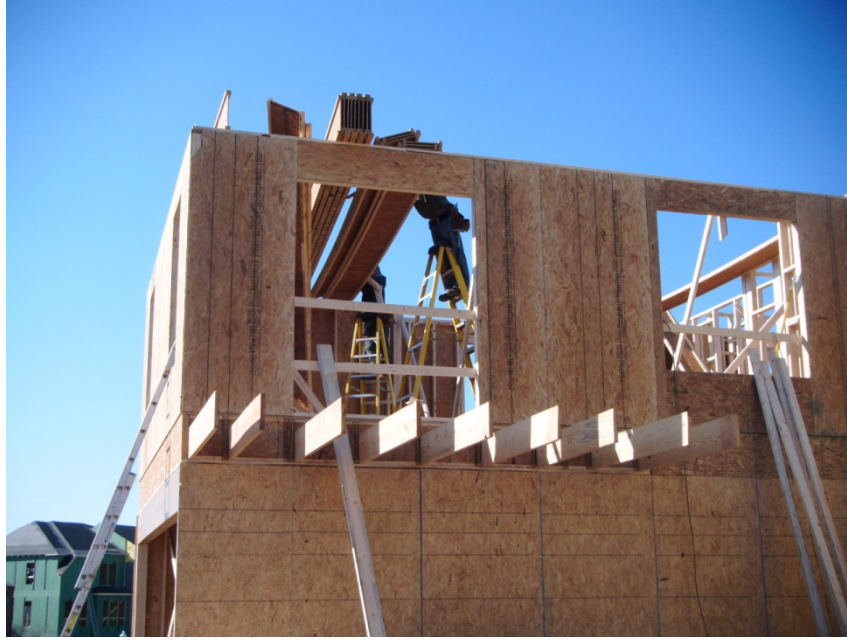
Exhibit 12. Framers installing second floor joists from ladders.

Walls can be raised using a self-retracting line and harness with anchor points installed at the feet (shown in Exhibit 12). Materials need to be properly staged to facilitate moving the walls to the proper location. Additional anchor points may be needed in order to facilitate material handling issues.

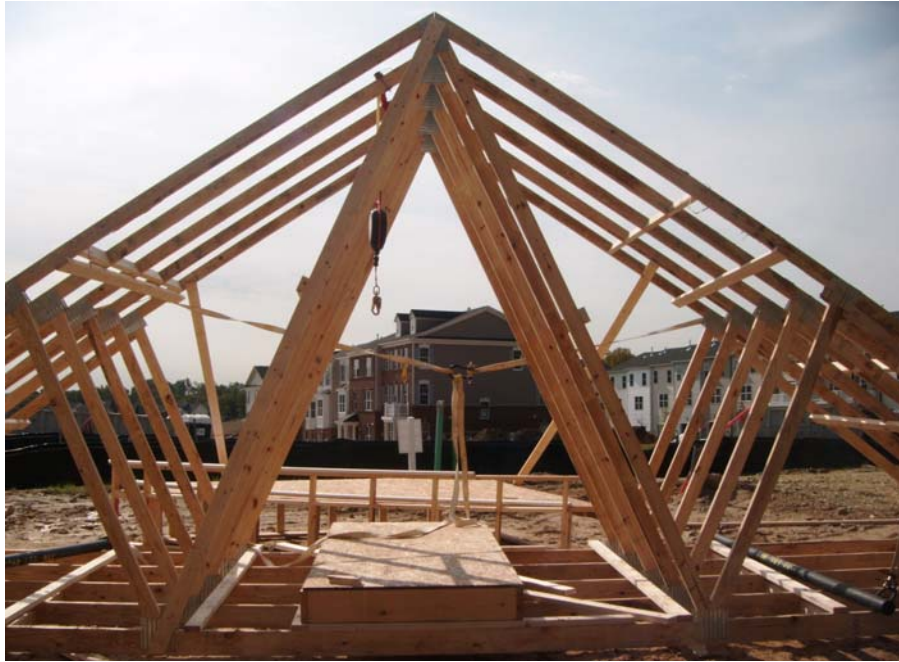
Exhibit 13. Braced trusses with temporary anchor point installed and self-retracting line.

In order to install an anchor point on the trusses that would meet the load requirements listed in Subpart M and ANSI Z359, the manufacturer's bracing recommendations, listed in BCSI-2 and BCSI-11 (BCSI 2011), need to be followed. Five trusses are braced on the ground and an anchor point spanning at least two trusses is installed (shown in Exhibit 13). A self-retracting line is attached to it, and then the braced trusses are lifted with a crane and set in place (shown in Exhibit 14). Once the five braced trusses are set on the walls, a framer can climb up a ladder and hook his harness to the self-retracting line, then climb up on the top plate of an inside wall or the web of the trusses and continue to set the additional trusses (shown in Exhibit 15). Workers at the tails working from ladders will secure the trusses to the top of the wall (shown in Exhibit 16). The bracing of the trusses on the ground was conducted prior to the crane arriving on the jobsite. In approximately one hour, 3 to 4 framers working from ladders can have the five trusses braced and ready to be lifted. Additional lifting bars and bracing are needed to ensure the braced trusses would stay together during the lift. An engineer from our integrator who fabricates and installs all of the wood components for the home was onsite the first couple of times to ensure the proper bracing was being installed and the installation went smoothly.

Our integrator brought up liability issues related to the installation of anchors on the structure and their use by other contractors. Contractually, they are required to provide and install the anchor points per our instructions. For additional information on bracing trusses, refer to the BCSI. In 2011, the SBCA updated the BCSI-11 (BCSI 2011) safety recommendations with additional guidance on the installation of anchor points on trusses. Presently, these recommendations are followed (shown in Exhibits 13 and 14).

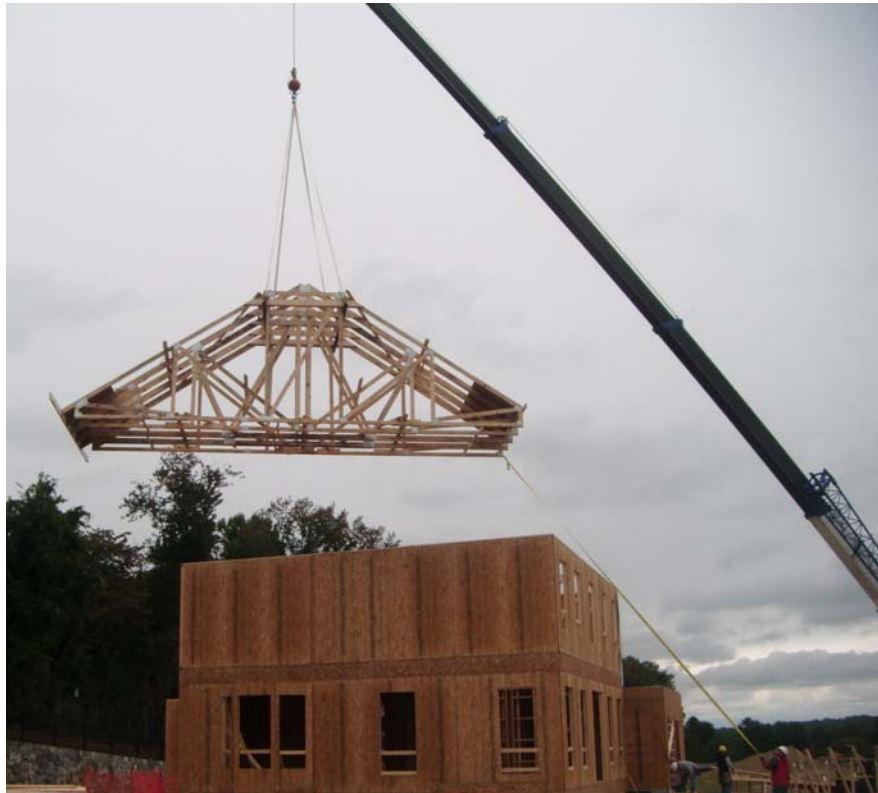
Exhibit 14. Braced trusses lifted by crane.

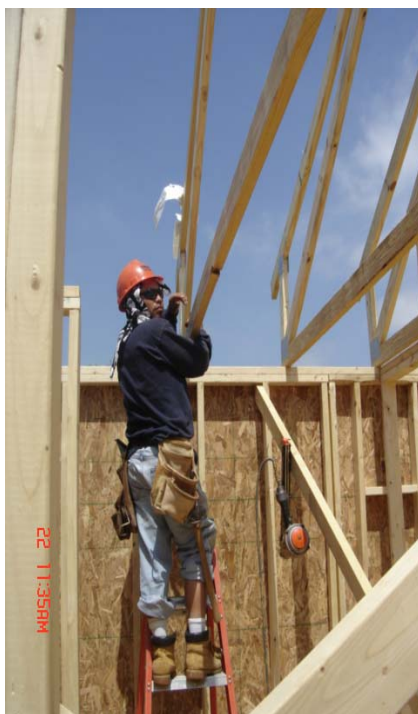
Exhibit 15. Worker working off of ladder while installing trusses.

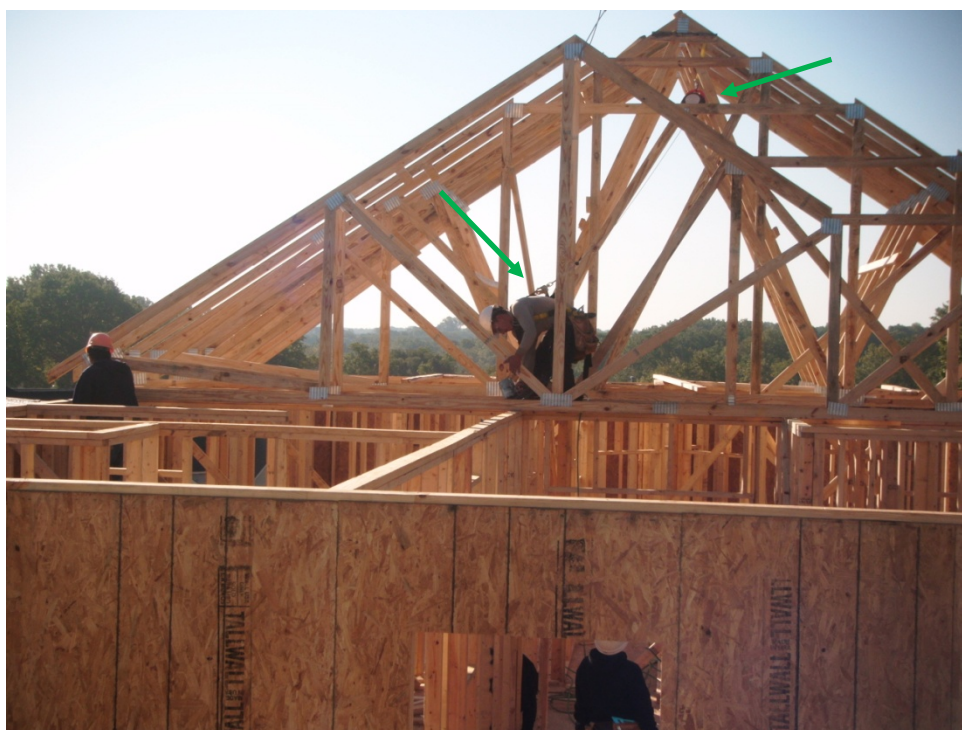
Exhibit 16. Worker using self-retracting line and anchor point installed in trusses to set trusses.

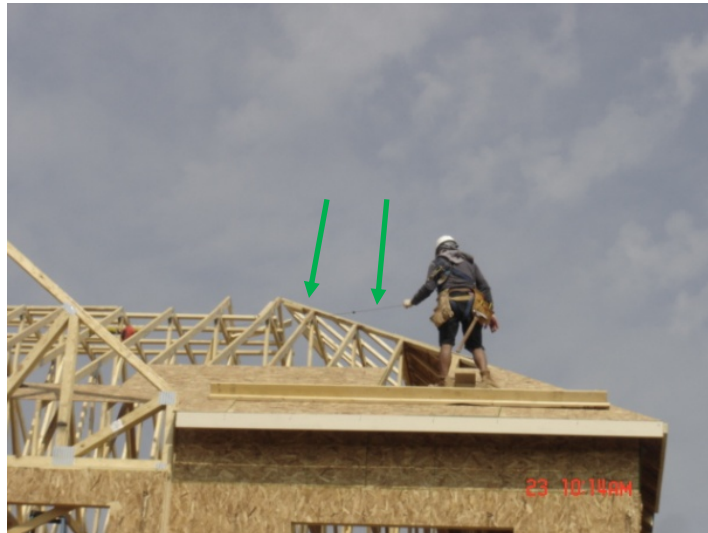
Exhibit 17. Worker sheathing roof using PFAS.
