Retired & Dangerous Out-of-Service Equipment Hazards

By Robert Wasileski

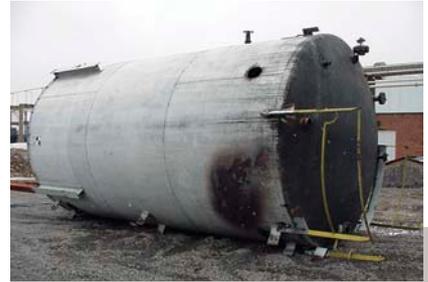
Photo 1 (above): Atmospheric storage tank following the fire.

During the process of removing the first nozzle with the cutting torch, a fire developed inside the tank (Photo 1). Attempts to extinguish the fire with handheld fire extinguishers were unsuccessful and a water fog was quickly introduced inside the tank to extinguish the fire. A large mass of solid foam-

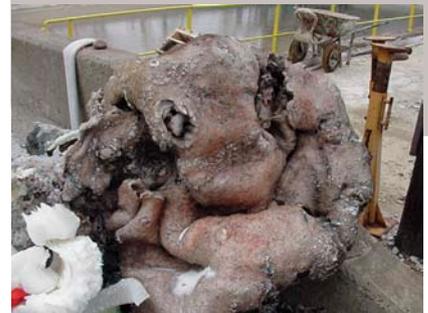
Photo 2: Combustible solid removed from the tank.

like material was later removed from the tank (Photo 2).

As one might suspect, the atmospheric testing that had been performed prior to hot work had not detected this combustible solid inside the tank. However, the presence of such a material was not expected, considering the tank had previously been in flammable liquid service. During the 15 years that the tank was out of service, an unanticipated hazard had materialized inside the tank and gone unnoticed. The exact mechanism(s) that led to the formation of this foam-like material were never fully understood. However, one explanation suggested that vinyl benzene monomer had been unintentionally introduced into the tank previously. A slow, uncontrolled polymerization of this monomer in the presence of cyclopentane created the amorphous foam-like combustible material discovered following the fire.

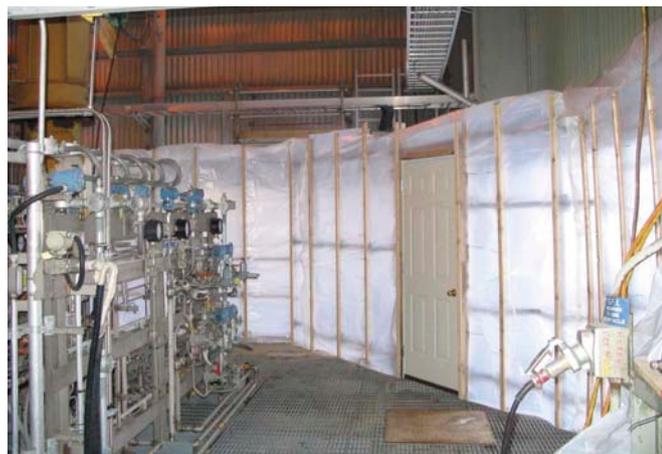
Photo 3 (above): Congestions and confinement created by equipment/buildings.

An additional concern related to vapor cloud explosion hazards arises when OOSE remains installed in a plant (i.e., it is not dismantled). Equipment such as pumps, piping, vessels, tanks and buildings can add unnecessary congestion and confinement to plant layouts (Photos 3 and 4). These physical obstacles can have a significant adverse impact on vapor cloud dispersion and flame-front speeds, particularly with materials that are susceptible to deflagration-to-detonation transition behavior (e.g., hydrogen, acetylene, ethylene).

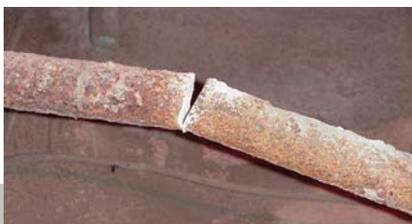
Photo 12: Piping
containing
sulfuric acid.

Prior to cutting the lines, maintenance personnel removed pipe hangers to allow the ends of both lines to slope toward the floor. There was no indication of liquid in the piping, as nothing had spilled from the ends and the lines were disconnected from other piping in the area. Shortly after making a cut into the second steel line, liquid began to spray from the pipe (Photo 12). Work stopped immediately, and an investigation was initiated.

The investigation concluded that the liquid was sulfuric acid from a system that had been (partially) decommissioned and out of service for nearly 25 years. Apparently, the acid had been trapped inside the piping by foreign material plugging off the pipe ends.

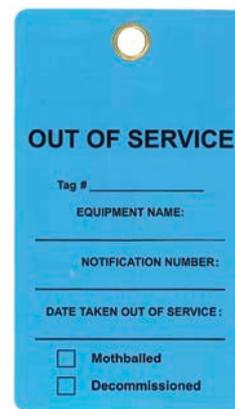
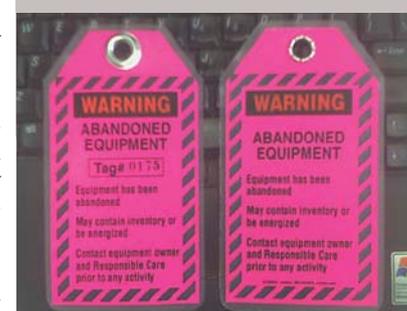
Photos 13 and 14: Examples of out-of-service-equipment tags.

An organized, deliberate effort to identify OOSE in the field is a necessary first step toward incident prevention. Including experienced operating staff in this effort is strongly recommended, as their knowledge and history with the plant will assist in this pursuit. OOSE must be identified as such, and it is generally recommended that a unique, weather-resistant tag be securely affixed to the equipment.

The tags raise awareness of the potential risks to maintenance and contract employees who may be required to work on the equipment in the future. As such, flanges, pipe unions, manway covers and other common line-break locations are logical attachment points for tags. Furthermore, the tags should include a unique alphanumeric identification system that will allow the OOSE inventory to be catalogued in a database. Suitable examples of OOSE tags have been included for illustration purposes (Photos 13 and 14).
