Analyzing a Fatal Crane Accident

Investigation reveals practical preventive measures

By Wayne Johnson and Risto Rautiainen

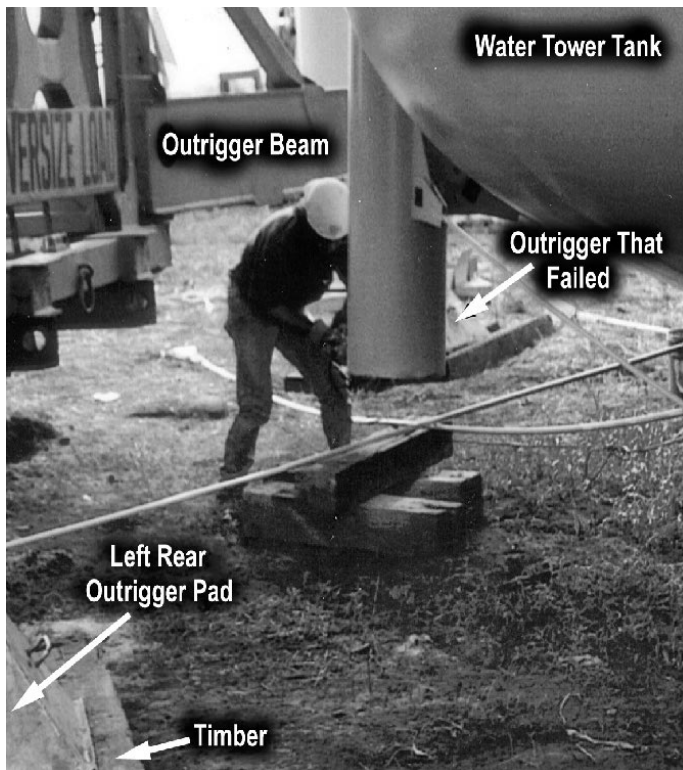
the tank crew, who was positioned inside the ladder cage for the water tower, and the crane operator, who was sitting inside the control box of the crane 120 ft. above the ground. Photo 1 was taken just a few minutes before the crane fell.

(Clockwise from top, left): Photo 1: The water tower minutes before the incident.

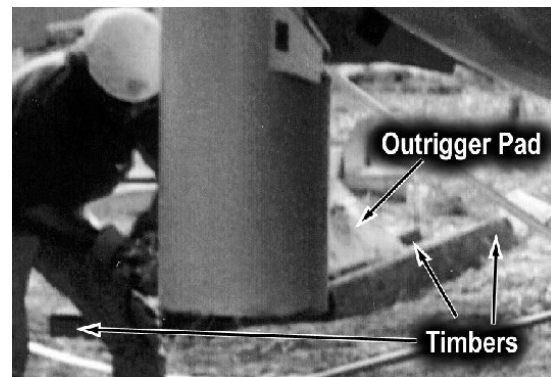
Photo 5: Close-up of timbers under the right outrigger that failed 20 minutes later.

Shortly before the final lift, the water tank was raised a few feet off the ground to clean the bottoms of the support legs (Photo 4). This photograph shows a glimpse of the outrigger and cribbing timbers that failed 20 minutes later. A closer look reveals some noteworthy details (Photo 5): 1) the ground is not level under the timbers; 2) the cribbing timber to the right has already begun to roll out from under the pad; and 3) space is evident between the right and middle timbers. The appearance of the timbers is consistent with their final position after the accident (Photo 6).

Recommendation 1: Crane owners and operators should ensure that cranes are properly set up with the outrigger pads supported by stable footing.

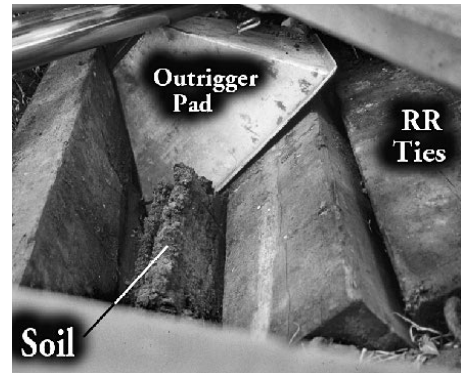
Photo 6: Failed outrigger pad and cribbing timbers.

The investigation concluded that the crane tower fell directly in line with, and on top of, the right rear outrigger, with complete failure of the ground under the right rear outrigger occurring soon after the full load was upon it. Although the top of the ground in the area was dry, deeper soil under the three timbers was wet and soft. The weight of the load squeezed this soil upward between the timbers. The trailer's right rear dual tires left a depression approximately 18 in. deep
