# Slips & Falls

*Employee experience and perception of floor slipperiness:*

*A field survey in fast-food restaurants*

**By Kai Way Li, Theodore K. Courtney, Yueng-Hsiang Huang, Wen-Ruey Chang and Alfred J. Filiaggi**

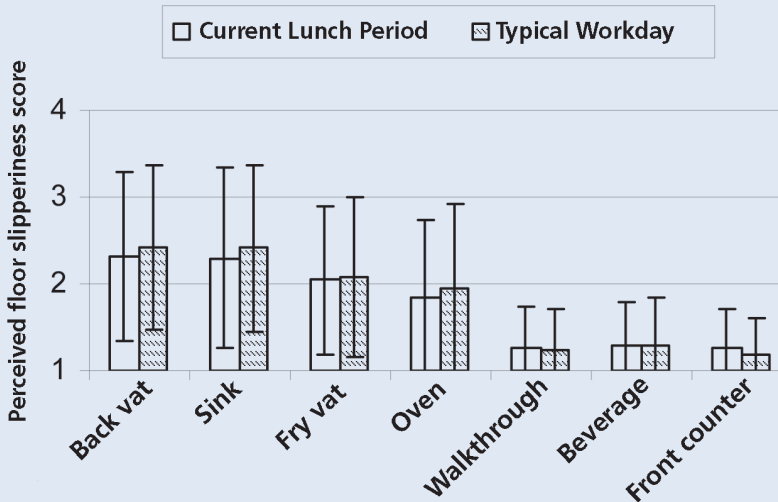
Figure 1

## Perceived Slipperiness for Major Areas in Restaurant Kitchens

Note. Rating scale: 1 = not slippery to 4 = extremely slippery.

Participants were asked to rate each area from 1 to 4, with 1 being not slippery and 4 being extremely slippery based on floor conditions they experienced during the lunch period on that day. In a subsequent section of the survey, participants were asked to provide the same ratings of the same areas based on a typical workday. The mean ( $\pm$ SD) floor slipperiness scores are shown in Figure 1.

Most employees had slipped or fallen within the prior 4 weeks at work and expected to do so again. The areas most frequently cited as the location of the slip or fall (Figure 3) event were consistent with areas employees rated as most slippery (Figure 1). Interestingly, as noted, the perception-rated areas

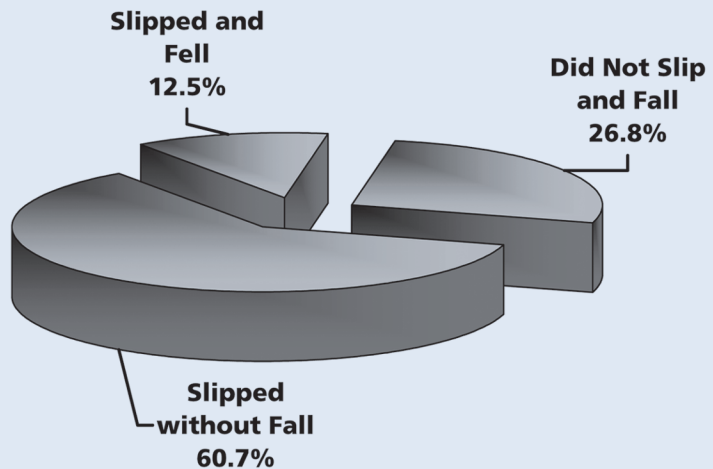
**Figure 2**

**Worker Slip & Fall Experience within Prior 4 Weeks**

Participants were asked about their experience with slips and/or falls at work in the past 4 weeks. Among the interviewees, the number (percentage) of those who did not slip and fall, who slipped without falling, and who slipped and fell were 15 (26.8%), 34 (60.7%) and 7 (12.5%), respectively (Figure 2). The percentage of slipping with/without falling (73.2%) was surprisingly high even though no participant reported an injury from a falling event. In two restaurants, every participant had slipped either with or without a fall in the prior 4 weeks.

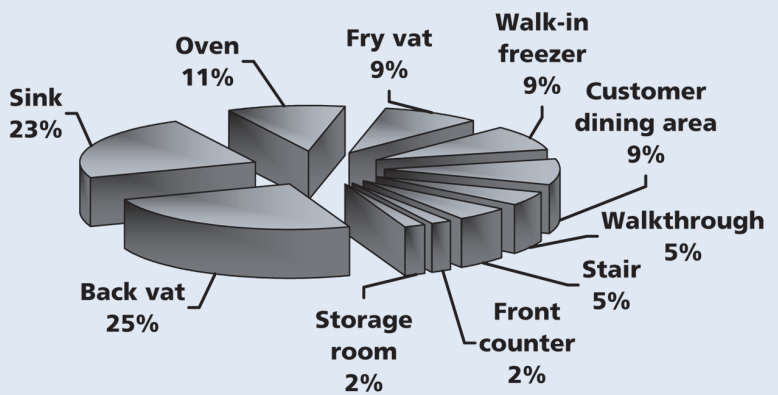
**Figure 3**

**Locations of Employee Slips**

Note. Locations of employee slips with (n = 7) and without (n = 41) fall.

The 73% of workers who slipped and/or fell in the past 4 weeks were asked to indicate the location(s) where the event occurred. Figure 3 presents the results. Similar to perception reports, employees identified the back vat, sink, oven and fry vat areas most often. For the 7 falls, 2 occurred in the customer dining areas when the employees stepped on a freshly mopped area while mopping before the end of the business day. Two falls occurred on the wet

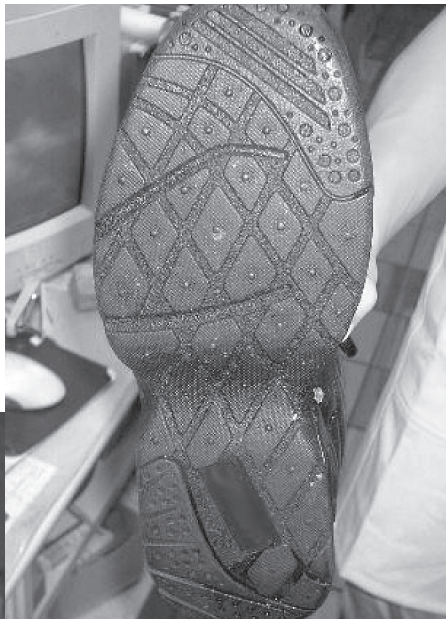
(From top) Photo 1: Shoes with soles that are not worn.

The shoe soles were rated as either not worn, partially worn and fully worn. Shoes rated as not worn were normally new or appeared to be in near-new condition. The fully worn shoes were those with fully worn tread grooves. In fact, some participants commented that their shoes were so badly worn that they believed the shoes should be replaced immediately. Shoes that could not be classified as either not worn or fully worn were rated as partially worn. Photos 1, 2 and 3 (pg. 38) show examples of shoes classified in the three categories.

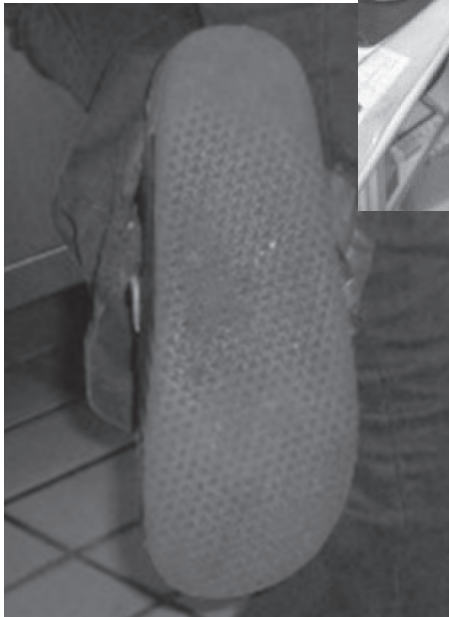
Photo 2: Shoes with soles that are partially worn.

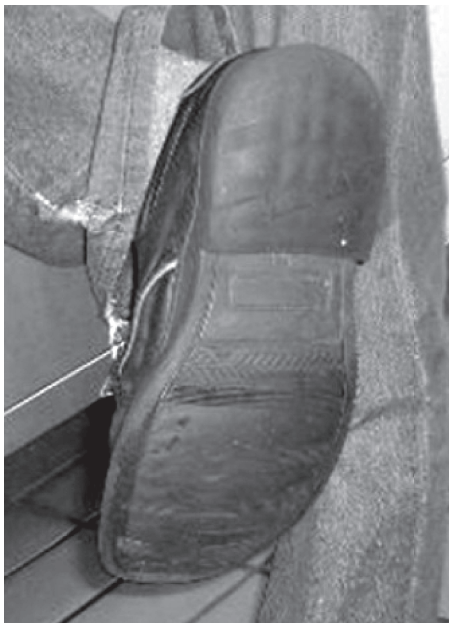
Photo 3: Shoes with soles that are fully worn.
