Implementing Effective Fall Protection Practices in Residential Construction Update

**Thomas Trauger, ARM
Winchester Homes
Bethesda Maryland**

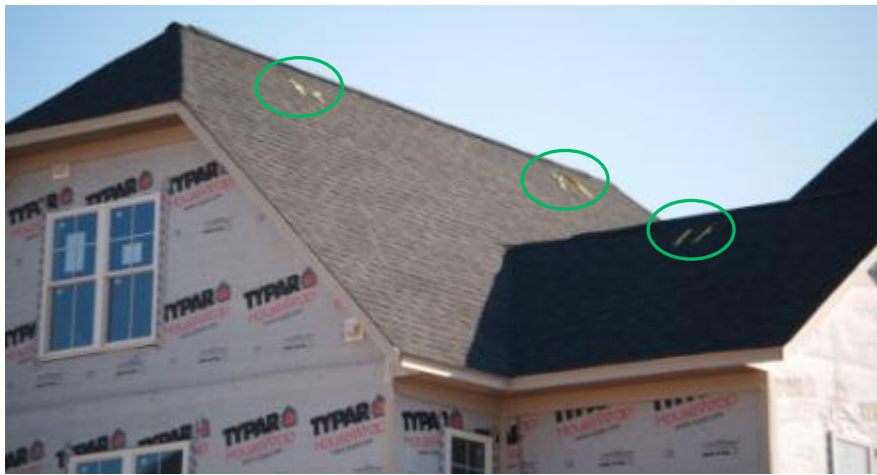
Exhibit 1. Permanent roof anchors installed for trades to use.

Winchester Homes is one of five companies that is part of the Weyerhaeuser Real Estate Companies (WRECO) and builds homes in Maryland and Virginia. Winchester Homes both develops land and buys finished lots to build single-family homes and town homes. Using the “Your Home Your Way” process buyers can modify the home at will. Therefore Winchester seldom builds the same house twice. Besides options and finishes, major structural changes are commonly conducted on base type homes. Over 100 sub contractors are used to complete over 100 building phases. In 2007, the WRECO management team started the implementation of fall protection practices that met or exceeded Sub Part M, phasing out practices that met the OSHA interim fall protection guidelines (OSHA STD 03-00-001). Permanent roof anchor points have been installed on all Winchester Homes sites for over 8 years (shown in Exhibit 1).

Once all of the trusses are set and braced the roof sheathing process starts. Permanent anchor points are then installed in each roof plane. Depending on the size of the home more than one anchor point may be installed on the roof plane (shown in Exhibit 1). The worker hooks in to the permanent points with a retractable line and harness and continues sheathing the roof (shown in Exhibit 17). Any additional work conducted on the roof can be done using the permanent anchor points and PFAS.

completed (shown in Exhibit 1). These anchor points are used by several trades working on the roof. Using anchor points on fully sheathed roofs meets the truss manufacturer's recommendations and complies with Sub Part M and ANSI Z359 requirements. A fall protection solution for framers working off of inside walls while installing trusses and then sheathing the roof was needed (shown in Exhibit 15). In the past they would follow the interim fall protection guidelines, framers installed the first three trusses from a ladder and then temporarily braced them. Then the worker installing trusses in the middle of the house would climb into the web of the braced trusses and continue installing trusses. Sheathing was conducted by installing the first few boards from ladders and the web of the trusses, then installing slide guards and continue sheathing the roof (shown in exhibit 16). During this task they would install the anchor point.

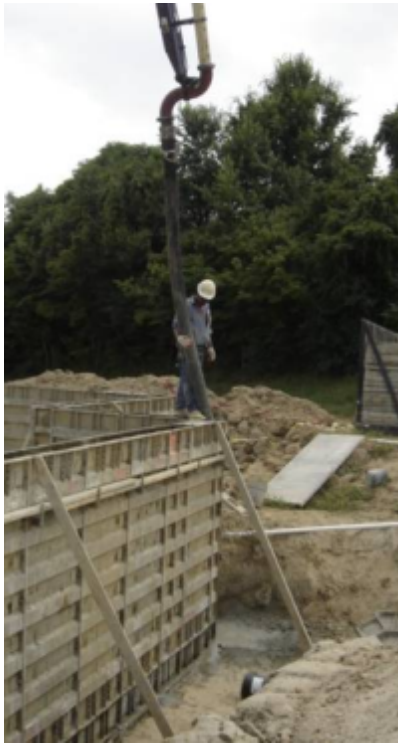
Exhibit 2. Concrete worker walking forms while pouring basement walls.

Most contractors doing this type of work for residential construction also do it for commercial construction; this made it easy to implement a safety practice on home building sites. The practice of walking the top of the form walls (shown in Exhibit 2) was eliminated by installing scaffold brackets on the forms and planks (shown in Exhibit 3). Installing and removing the brackets and planks require at least two workers and 2 to 3 hours of work depending on the size of the basement. The bracket and planks can be reused and prorated over 100 homes making the cost an overall low expenditure.

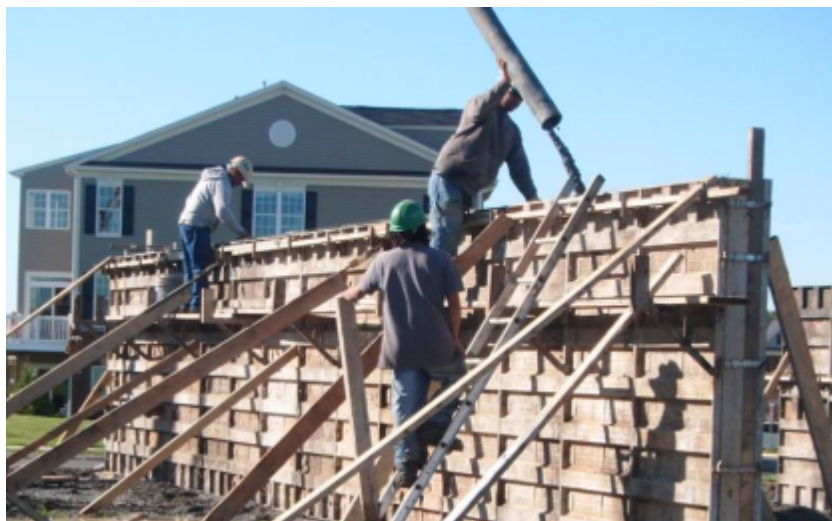
Exhibit 3. Concrete workers working off of bracket scaffold while pouring basement walls.

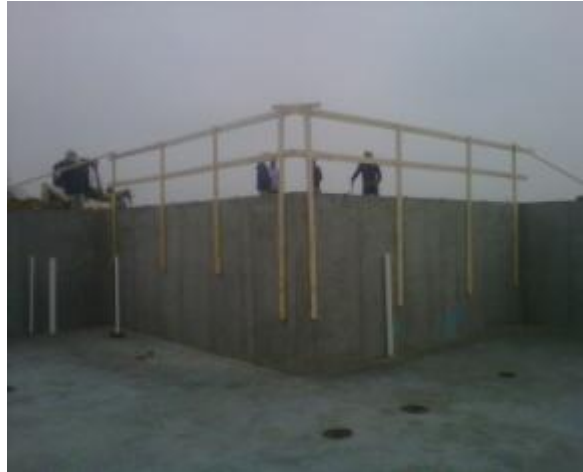
2x4 lumber is used to construct guardrails and attached to the basement walls. These guardrails will serve as fall protection for anybody that walks up to the house near the garage area. See Exhibit 4 for details.

Exhibit 4. Guard rails installed on basement walls

Once the concrete forms are removed there is a fall hazard were workers can fall into the basement. Guardrails are installed by the concrete contractor as soon as the forms are removed.

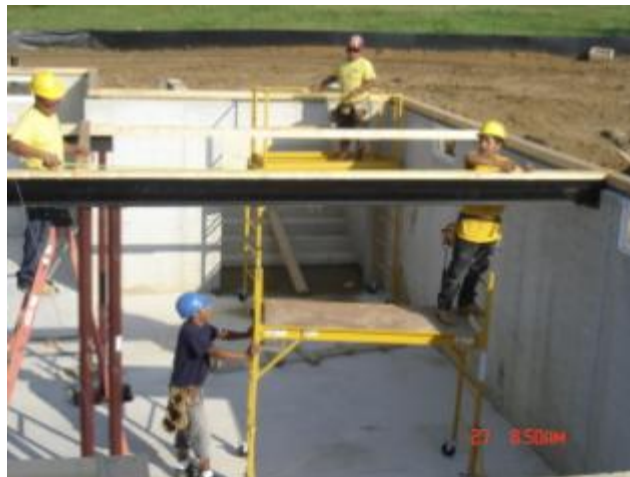
Exhibit 5. Workers setting sill plate on basement walls from ladders and mobile scaffold

The practice of walking basement walls and setting the sill plate and floor joists was eliminated. Framers can work from ladders or scaffolds to complete this task (shown in Exhibit 5 and 6)

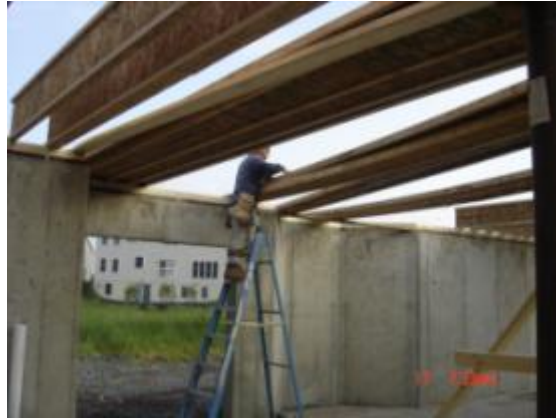
Exhibit 6. Framer working off of a ladder installing first floor joists.

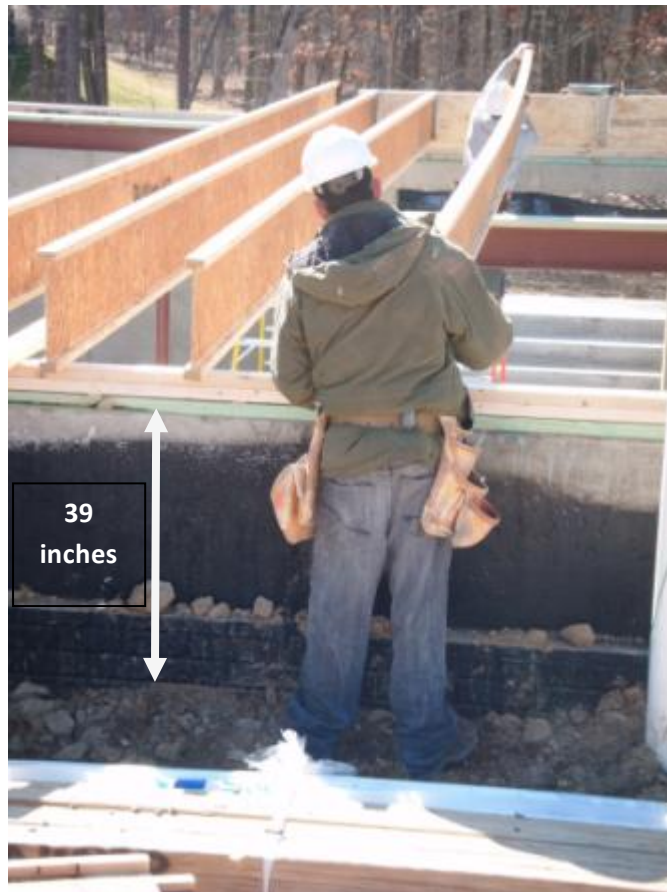
Exhibit 7. Framers installing floor joists from backfilled ground 39 inches from top of basement wall to ground and ladders

Another practice that was implemented was partially backfilling leaving 39 inches from the top of the basement walls to the ground (shown in exhibit 7). The basement wall acts as a guardrail preventing falls into the basement. This protects framers installing the sill plate, floor joists and sheathing. The excavator would come back after the house was framed to complete the backfill.

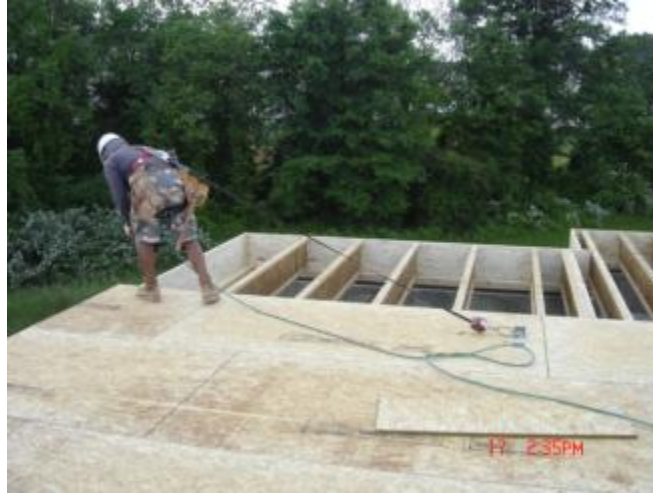
Exhibit 8. Worker using PFAS during installation of floor sheathing

When a walk out basement condition exists there will be a fall hazard greater than six feet from the edge of the first floor, a retractable line, harness and anchor point installed on the floor protects the worker from falls over the edge and falls between floor joists while sheathing the floors (shown in Exhibit 8).

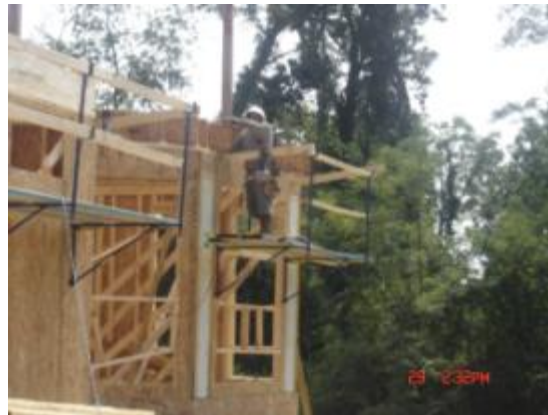
Exhibit 9. Framer working off of carpenter bracket scaffold installing second floor joists

Installation of second floor joists can be conducted from carpenter bracket attached to the first floor walls (shown in exhibit 9), horse scaffold (shown in exhibit 10) or ladders (shown in exhibit 12). Framers chose the use of ladders because of availability, ease of use and cost.

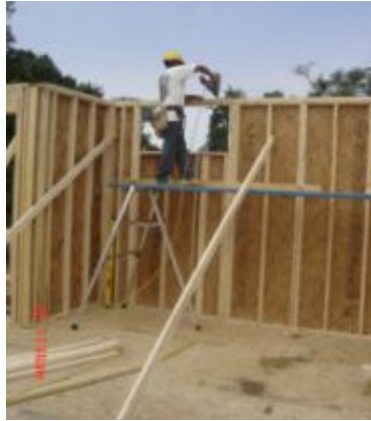
Exhibit 10. Framer working off of horse scaffold tying first floor walls together

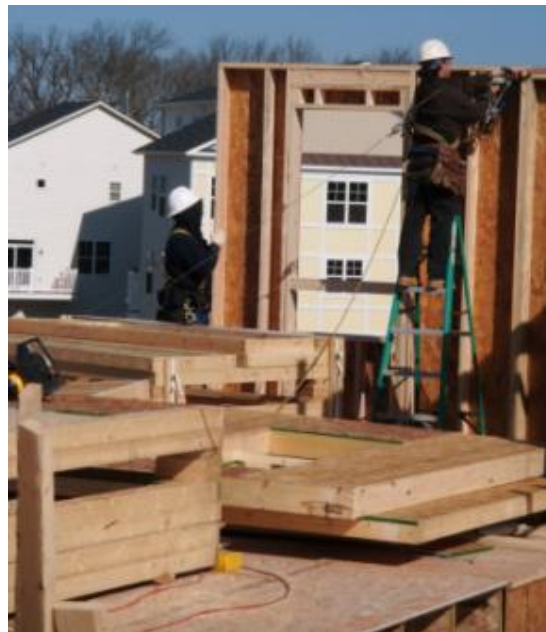
Exhibit 11. Framers installing second floor walls using self-retracting lines and anchor points installed on floor.

Walls can be raised using a self-retracting line and harness with anchor points installed at the feet (shown in Exhibit 11). Materials need to be properly staged to facilitate moving the walls to the proper location. Additional anchor points may be needed in order to facilitate material handling issues and avoid swing fall hazards.

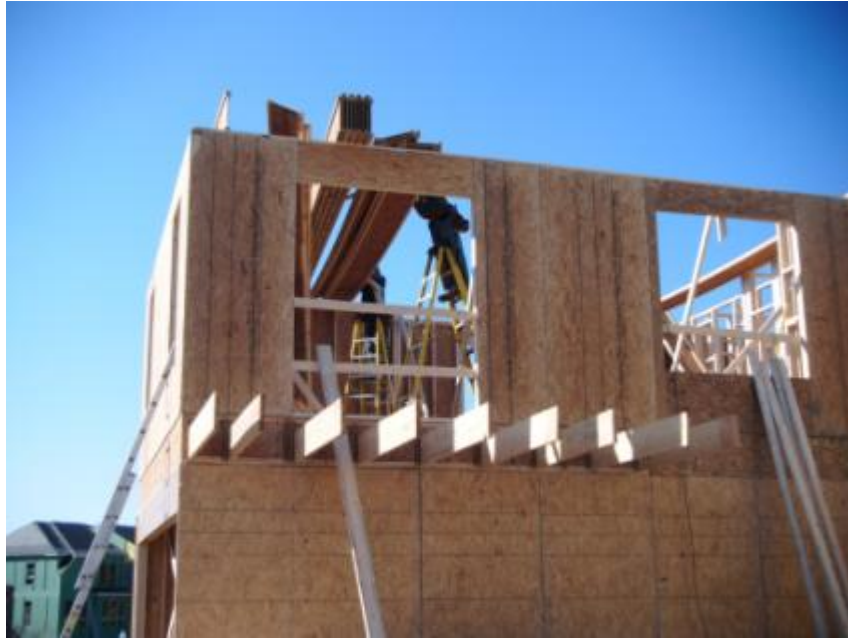
Exhibit 12. Framers installing second floor joists from ladders.

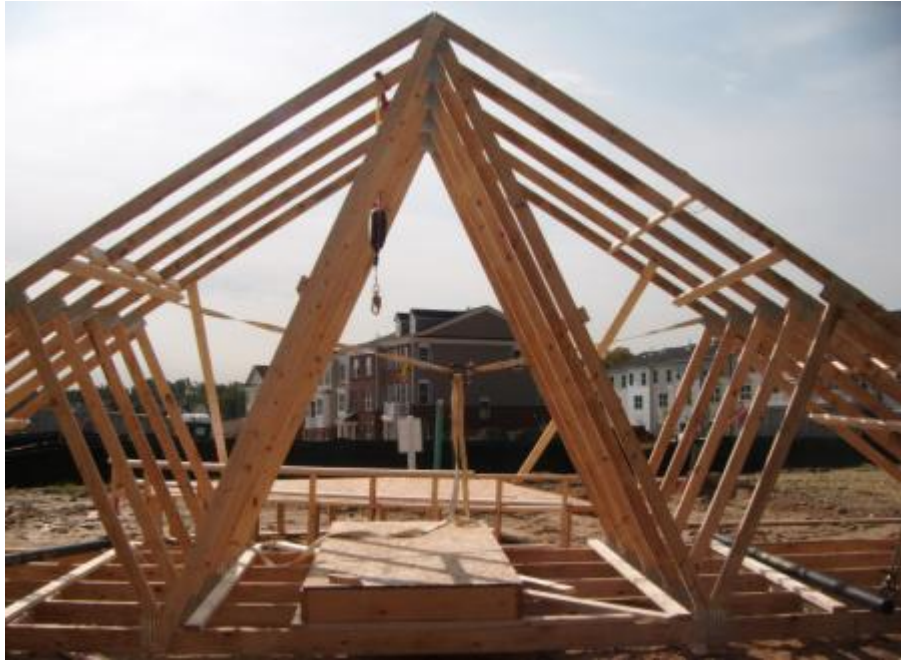
Exhibit 13. Braced trusses with temporary anchor point installed and self-retracting line.

In order to install an anchor point on the trusses that would meet the load requirements listed in Subpart M and ANSI Z359, the manufacturers bracing recommendations listed in BCSI-2 and BCSI-11 (BCSI 2011) need to be followed. Five trusses are braced on the ground and an anchor point spanning at least two trusses is installed (shown in Exhibit 13). A self-retracting line is attached to it and then the braced trusses are lifted with a crane and set in place (shown in Exhibit 14). Once the five braced trusses are set on the walls a framer can climb up a ladder and hook his harness to the self retracting line then climb up on the top plate of an inside wall or the web of the trusses and continue to set the additional trusses (shown in Exhibit 16). Workers at the tails working from ladders will secure the trusses to the top of the wall (shown in Exhibit 15). The bracing of the trusses on the ground was conducted prior to the crane arriving on the jobsite. In approximately one hour, 3 to 4 framers working from ladders can have the five trusses braced and ready to be lifted. Additional lifting bars and bracing are needed to ensure the braced trusses would stay together during the lift. An engineer from our integrator who fabricates and installs all of the wood components for the home was onsite the first couple of times to ensure the proper bracing was being installed and the installation went smoothly.

Our integrator brought up liability issues related to the installation of anchors on the structure and their use by other contractors. Contractually they are required to provide and install the anchor points per our instructions. For additional information on bracing trusses refer to the BCSI. In 2011 the SBCA updated the BCSI-11 (BCSI 2011) safety recommendations with additional guidance on the on the installation of anchor points on trusses. Presently these recommendations are followed. (shown in Exhibit 13 and 14)

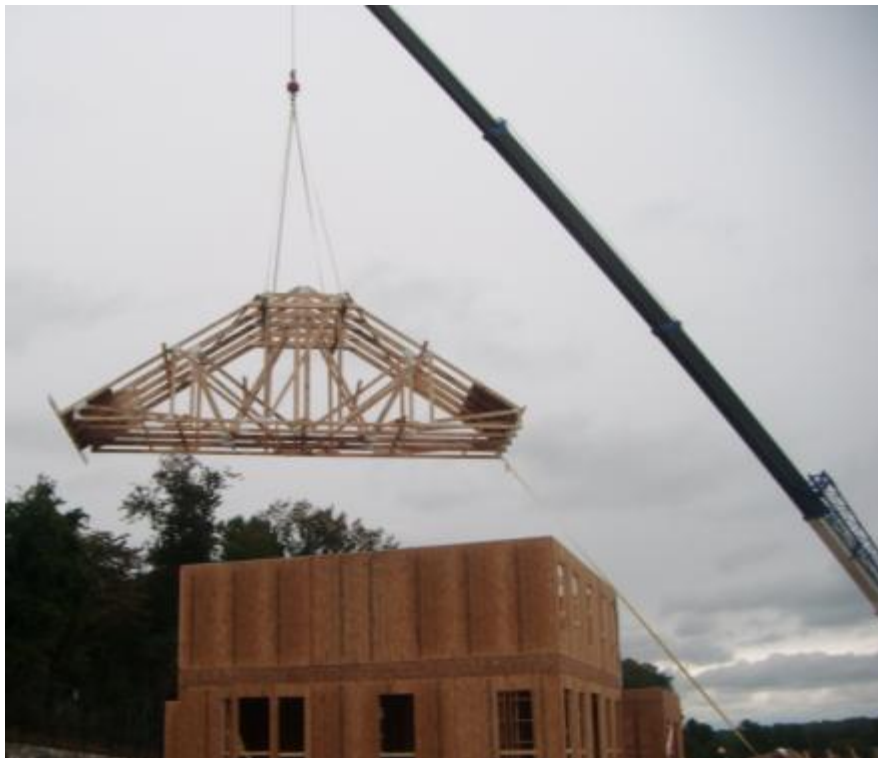
Exhibit 14. Braced trusses lifted by crane

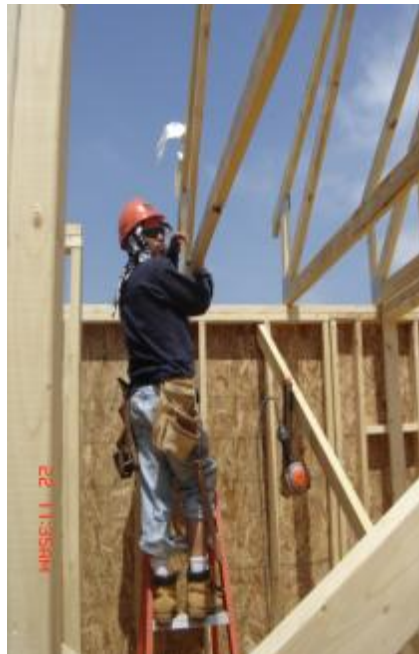
Exhibit 15. Worker working off of ladder while installing trusses.

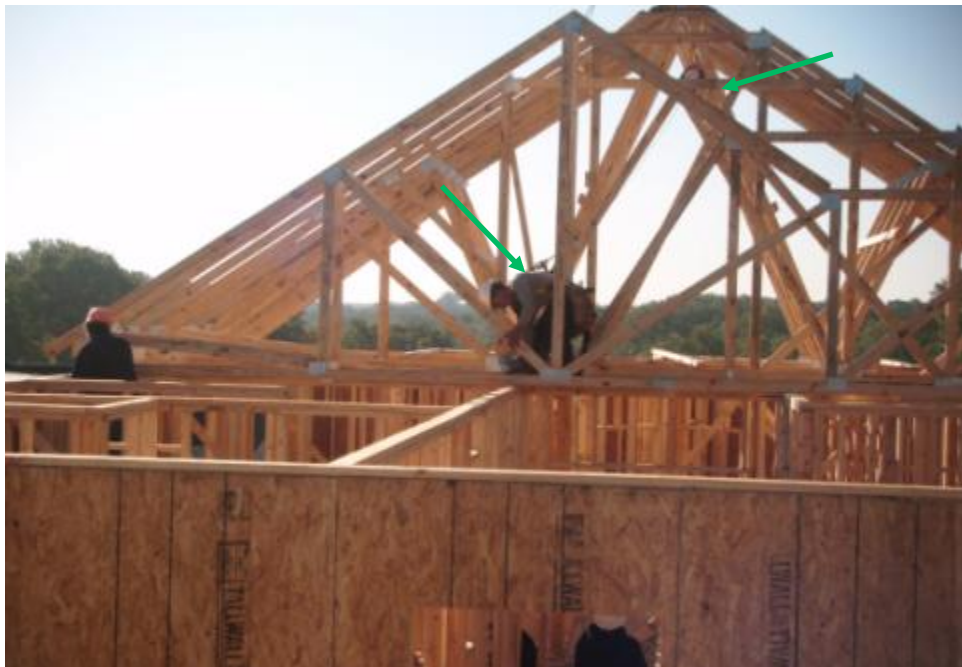
Exhibit 16. Worker using self retracting line and anchor point installed in trusses to set trusses

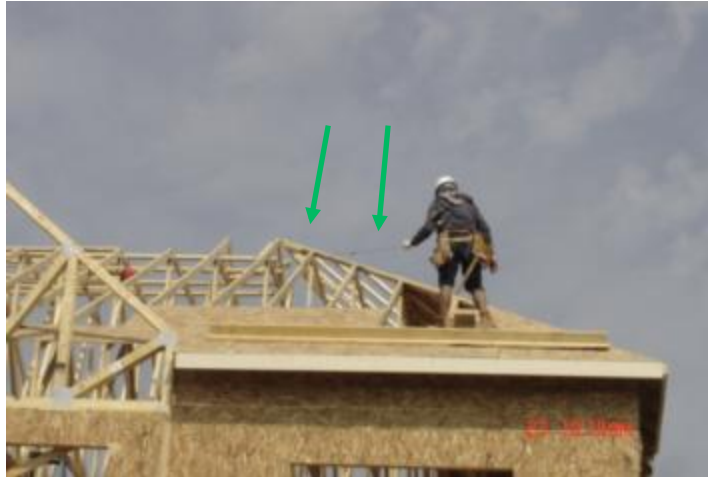
Exhibit 17. Worker sheathing roof using PFAS

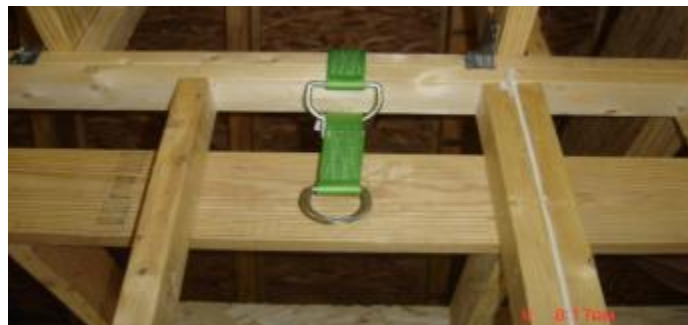
Exhibit 18. Anchor strap installed on double top plate of interior wall

There are many tasks conducted inside the home that expose workers to falls above 6 ft. Mobile scaffolds and ladders can be used for many tasks, however there are tasks where this is not possible. For these tasks temporary anchor points are used (see Exhibit 18 and 19).

The following are the two main concerns related to the use of temporary anchor points for interior work: strength of the structure where the anchor point will be attached and swing hazards. Attaching anchor straps to a single 2x4 will not meet the OSHA 5000 lbs requirements. A qualified worker needs to make a decision where to install the temporary anchor point. Multiple anchor points may be needed to prevent swing fall hazards.

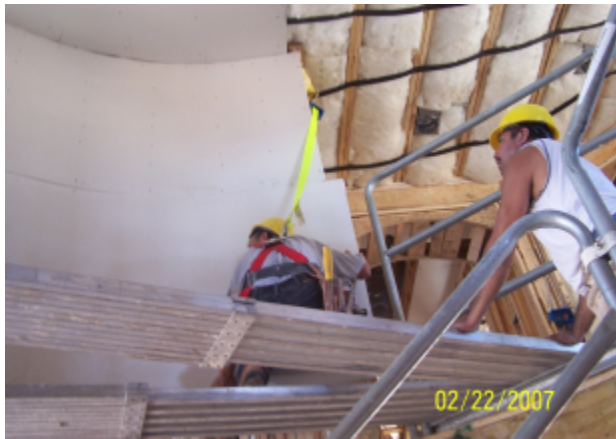
Exhibit 19. Dry wall hangers using PFAS with retractable lines in stairway area.
